Accessibility Report

Yorkton

Accessibility Review and Prioritized Recommendations

Project Number: 2025-073

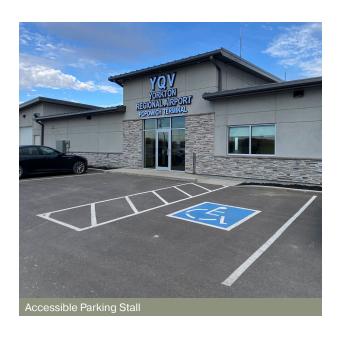
The building has one designated accessible parking stall that has an access aisle with a curb cut/level threshold at the top of aisle. However, the aisle width is insufficient, and the parking stall does not have vertical signage. The stall also lacks a canopy.

Parking					
Item	Concern	Recommendation	Priority and Budget		
			Short Term	Mid Term	Long Term
1	Access aisle is insufficient width.	Increase size of access aisle adjacent parking. Access aisle to be a minimum of 2000 mm wide. Create curb cuts at access aisle location. Ensure curb cuts are colour contrasted and have tactile attention indicators (TAIs).		\$5,000	
2	No signage on vertical surface designating accessible stall.	Provide signage on vertical surface designating accessible stall.	\$1,500		
3	No shelter above accessible stall.	Install shelter above designated accessible stall.			\$25,000
		Sub-total	\$1,500	\$5,000	\$25,000

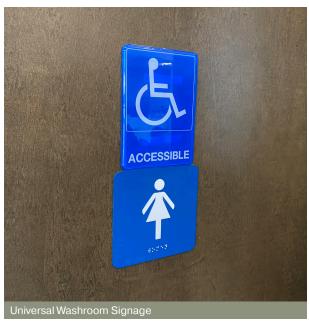
Universal Washrooms

While some components have been installed at good heights, several washroom accessories are mounted too high and/or too far from the toilet. The washrooms are missing several other components for accessibility. Generally, there is insufficient contrast between the floor, walls, and toilet in the washrooms.

Item	Concern	Recommendation	Pric	ority and Bud	dget
			Short Term	Mid Term	Long Term
1	Grab bars are two different heights.	Revise grab bars to be the same height. Centerline of horizontal grab bars to be 850 mm above floor.	\$1,500		
2	Tampon disposal is too high and too far from toilet.	Lower tampon disposal to no more than 700 mm above floor, mount adjacent toilet paper.	\$500		
3	Toilet paper is too far from toilet.	Move toilet paper to be closer to toilet.	\$500		
4	Paper towel is too high.	Lower paper towel to no more than 1100 mm above floor.	\$500		
5	Coat hook is located on the back of the door.	Install coat hooks no more than 1100 mm above floor and ensure coat hooks are on walls and not the backs of stall doors.	\$500

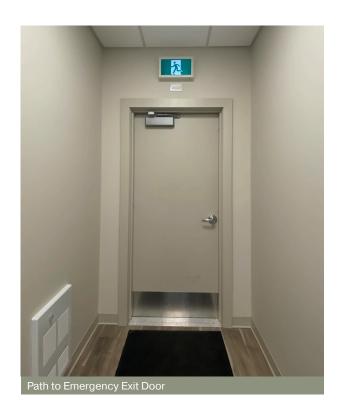
Emergency Exits and Areas of Refuge

The emergency exit door at the office corridor lacks sufficient contrast with the walls and could blend together for someone with visual impairment. The air-side emergency exit glazed door lacks sufficient visual contrast. Both of these exit doors lack an accessible path away from the building.

Item	Concern	Recommendation	Priority and Budget		
			Short Term	Mid Term	Long Term
1	Corridor emergency exit lacks visual contrast with walls.	Paint door to have at least 70% contrast with walls.			\$1,000
2	Air-side emergency exit glazed door lacks sufficient visual contrast.	Add colour-contrasting strips on full width of glazing.	\$1,500		
3	Both emergency exits lack accessible path away from building.	Provide smooth, stable, and slip resistant path of travel from all egress doors to designated muster point.			10000
		Sub-total	\$1,500	\$0	\$11,000

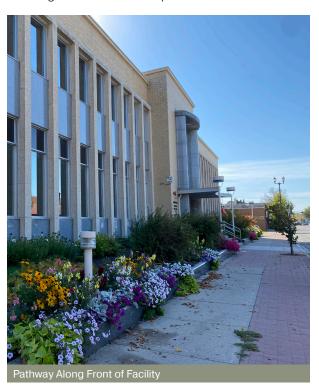
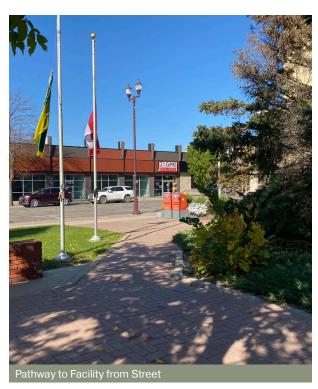
Exterior Pathways to Facilities on Site

The exterior pathways have well-maintained planters along them. However, the sidewalk in front of the building is constructed of pavers.

Exterior ruthways to rubinities on one							
Item	Concern	Recommendation	Priority and Budget					
			Short Term	Mid Term	Long Term			
1	Sidewalk in front of building is constructed of pavers.	Replace pavers with pavement that is smooth, stable, and slip-resistant.			\$20,000			
	Sub-total Sub-total			\$0	\$20,000

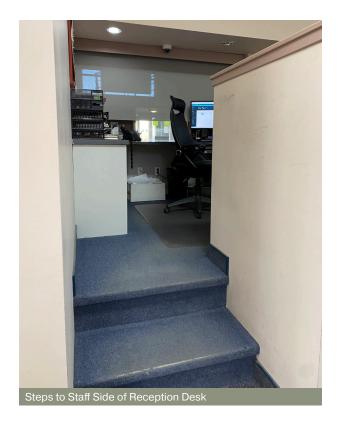
Path of Travel

The pathway to the council chambers from the back has multiple steps which has created a pinch point. There are more steps within the council chamber to create different levels of seating which has impacted the accessibility of the room. The steps throughout the space lack sufficient contrast, edge protection, and railings.

Item	Concern	Recommendation	Priority and Budget		dget
			Short Term	Mid Term	Long Term
1	Higher height of reception desk has steps on staff side.	Provide low slope ramp for access to reception desk.			\$5,000
2	Staff steps on reception desk lack handrails.	Provide handrails on both sides of all stairs.	\$2,500		
3	Staff steps on reception desk are too narrow.	Rebuild stairs to have a minimum of 1200 mm clear width.			\$5,000
4	Staff steps on reception desk lack tactile and contrast nosings.	Install colour contrasted and tactile strips on nosing of stair treads.		\$2,500

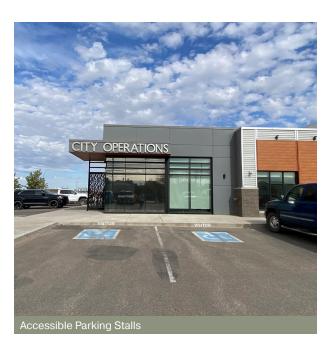
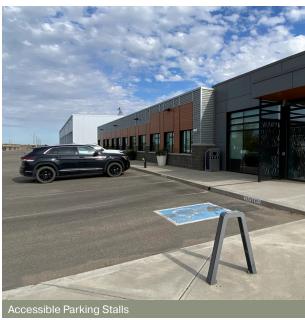
Parking

There are accessible parking stalls on site, but they lack access aisles, curb cuts, and a pedestrian path to the entrance. The stalls are missing vertical signage to help identify the stalls if the asphalt painting fades or if it is obscured by any snowfall for example.

Item	Concern	Recommendation	Pric	ority and Bud	lget
			Short Term	Mid Term	Long Term
1	Accessible stalls lack access aisles.	Create shared access aisles between accessible stalls. Access aisles to be a minimum of 2000 mm wide. Width of accessible parking stalls shall not be reduced to less than 2600 mm to create access aisles. Access aisles can be shared between two adjacent stalls.		\$5,000

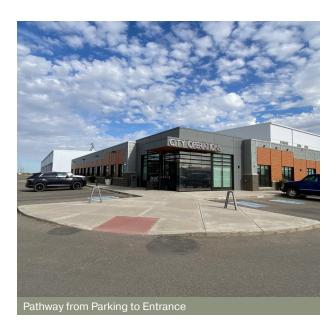
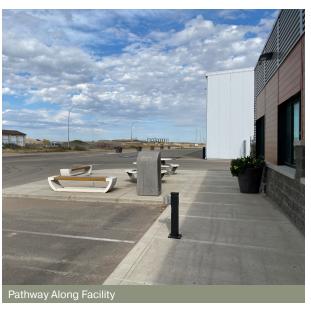
Exterior Pathways to Facilities on Site

There are well-maintained planters, however, they impede the pedestrian walkway around the building.

Item	Concern	Recommendation	Priority and Budget		
			Short Term	Mid Term	Long Term
1	Sidewalk clear width is impeded by planters.	Relocate planters to ensure a minimum of 1600 mm wide paths at all times.			\$2,500
		\$0	\$0	\$2,500

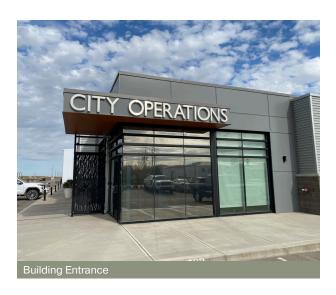
While there is an automatic door, the push button is only one height and is tucked behind a shading panel from the exterior. The doors generally lack visual contrast with the glazing walls.

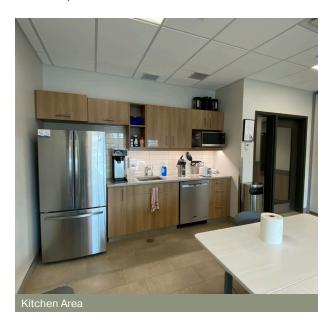
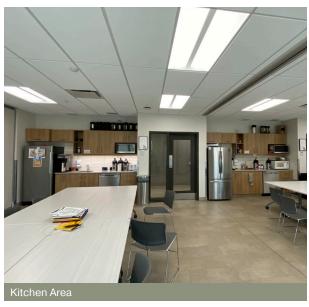
There are several kitchenettes within the building (in the multipurpose meeting rooms and a staff room). While fridges with no freezer or freezer-on-bottom are used, the counters are typically too high with sharp corners. The counters lack knee space at the sinks and for a working area. The floor tile also carries up the wall and creates a lack of contrast.

Kitchens							
Item	Concern	Recommendation	Pric	Priority and Budget			
			Short Term	Mid Term	Long Term		
1	Counters are too high. (Maintenance and Admin)	Replace millwork to accommodate lower counter. Top of counter to be no more than 860 mm above finished floor.		\$25,000			
2	No knee space under sink. (Maintenance and Admin)	Replace sink cabinet with version that has knee space. Knee space to be at least 685 mm high.		\$2,500

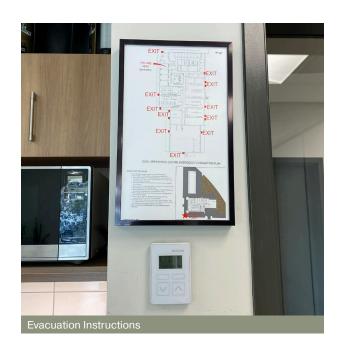
Evacuation Instructions

There are evacuation instructions mounted throughout the building that are matte which prevents glare. However, they are mounted too high and are only provided in one format.

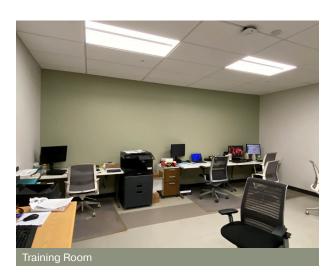
Office Spaces

The offices have a mixture of fixed and height-adjustable desks. It was noted during the walkthrough that height-adjustable desks are available upon request for city employees. However, the training room lacks height-adjustable desks. In the print room, the counter is too high and lacks a portion with knee space.

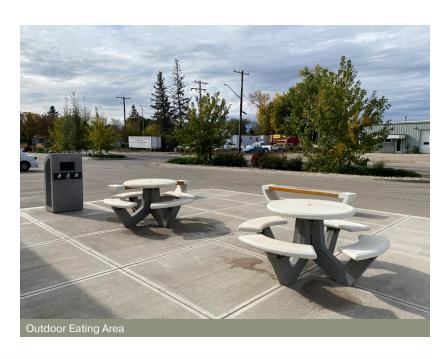
Outdoor Eating Areas

There is an outdoor patio with two tables provided outside of the staff room. However, it is only accessible from the exterior and lacks accessible seating and seating with arms.

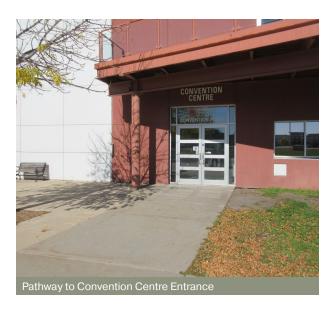
Exterior Pathways to Facilities on Site

The exterior pathways that lead to the Gallagher Centre is generally smooth with some areas in disrepair. There is a lack of designated pathways from the parking to the east building entrance.

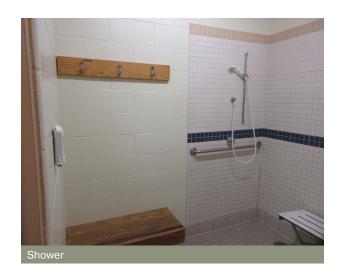
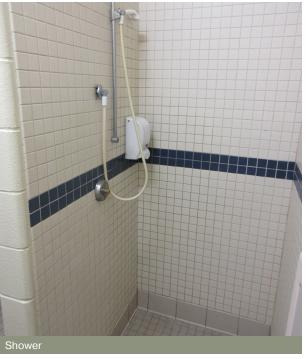
Showers

The Gallagher Centre has multiple different shower locations throughout the facility. At the time of review, the only functioning accessible shower was noted in the aquatic facilities family changeroom. All other showers within the Arena and Flexi-hall were either not accessible or non operating.

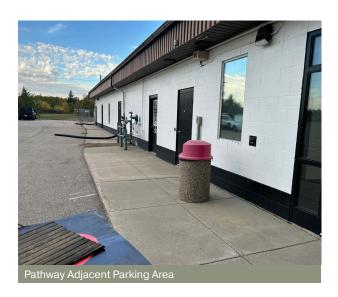
Exterior Pathways to Facilities on Site

The exterior pathways that lead to the Kinsmen Arena are flush with the adjacent parking surface and laneways without any contrasting or tactile surfaces at the thresholds. The pathways are also impeded at downspouts where weeping tile has been attached and laid out.

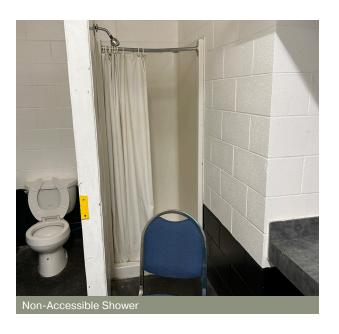
Showers

The Kinsmen Arena does not have any accessible showers.

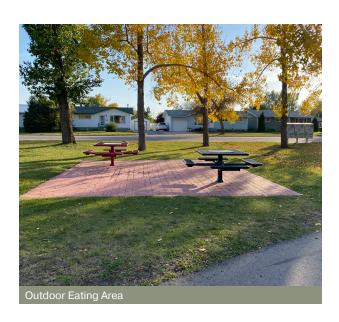
Outdoor Eating Areas

There is an area with tables and seating with chess tables, but they do not have accessible seating and lack paving from the main pathway.

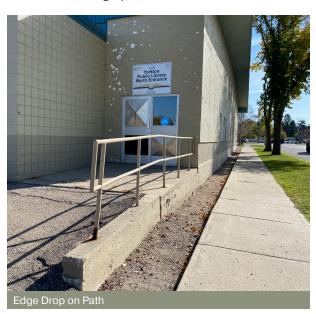
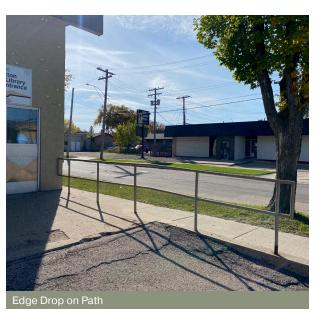
Exterior Pathways to Facilities on Site

There is a pathway at the west end of the building that leads to the back of the building that has a drop-off and lacks edge protection.

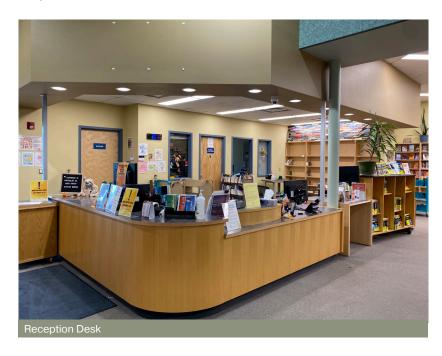
Reception Desks, Service Counters, and Self-Service Transaction Kiosks

There is an accessible height portion available at the front desk, however, it is far from the entrance and is covered with pamphlets and materials. On the staff side, the desk does not have height adjustability.

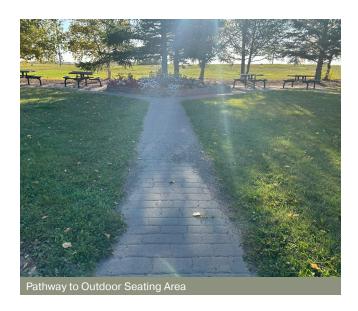
Trail and Pathway Features

The Tourist Information building has additional outdoor spaces that include pathways to a picnic seating area and an outdoor educational crop walking tour.
