Accessibility Report

Yorkton

Accessibility Review and Prioritized Recommendations

Project Number: 2025-073

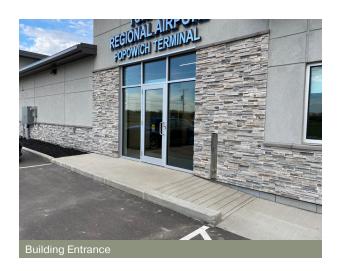
Building Entrances

The building entrance is obvious with its signage and open space in front of the main doors. The main entrance has a variety of height with its long push button actuator, but the door is quite heavy when not using it. When using the power doors, they open and close too quickly and lack sufficient hold-open time. The entrance also lacks a canopy with seating and sufficient contrast between the entry door and adjacent glazing walls.

Item	Concern	Recommendation	Pric	rity and Bud	lget
			Short Term	Mid Term	Long Term
1	Doors are heavy when not using push button actuators.	Adjust door to require less force to open. Exterior swing doors to require no more than 38 N of force.	\$500		
2	Power doors open and close too quickly and lack sufficient hold open time.	Program door actuator to close slower and to hold open longer.	\$500		
3	Entrance doors lack sufficient visual contrast.	Add colour-contrasting strips on full width of door glazing.	\$1,500		
4	Entrance doors lack sufficient contrast with adjacent glazed walls.	Refinish door to provide contrast with adjacent walls.			\$5,000
5	Entrance does not have canopy.	Provide canopy at main entrance.			\$15,000
6	Entrance does not have seating.	Install seating at the main entrance.		\$2,500	
7	No designated service dog relief area.	Designate area close to main entrance as a service dog relief area. Ensure designated area is clearly marked and accessible.		\$500

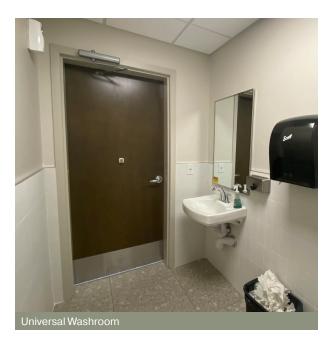
Universal Washrooms

While some components have been installed at good heights, several washroom accessories are mounted too high and/or too far from the toilet. The washrooms are missing several other components for accessibility. Generally, there is insufficient contrast between the floor, walls, and toilet in the washrooms.

Item	Concern	Recommendation	Pric	ority and Bud	dget
			Short Term	Mid Term	Long Term
1	Grab bars are two different heights.	Revise grab bars to be the same height. Centerline of horizontal grab bars to be 850 mm above floor.	\$1,500		
2	Tampon disposal is too high and too far from toilet.	Lower tampon disposal to no more than 700 mm above floor, mount adjacent toilet paper.	\$500		
3	Toilet paper is too far from toilet.	Move toilet paper to be closer to toilet.	\$500		
4	Paper towel is too high.	Lower paper towel to no more than 1100 mm above floor.	\$500		
5	Coat hook is located on the back of the door.	Install coat hooks no more than 1100 mm above floor and ensure coat hooks are on walls and not the backs of stall doors.	\$500

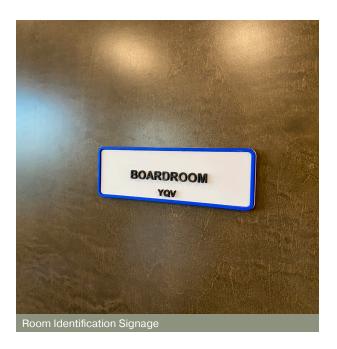
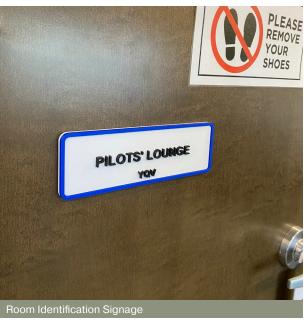
The room identification signage is mounted on doors. While the signage is tactile, it lacks Braille.

Item	Concern	Recommendation	Priority and Budget		
			Short Term	Mid Term	Long Term
1	Signage is located on doors.	Replace signs on doors with latch-side, wall mounted signs at 1500 mm. Signage to be high contrast, tactile, and include Braille.	\$4,500		
2	Signage has tactile but no Braille.	Replace signage with versions that have both tactile and Braille components.	Included in Room Identification Signage item #1		
		\$4,500	\$0	\$0

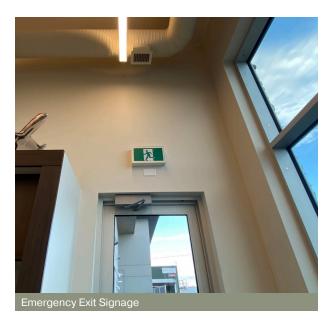
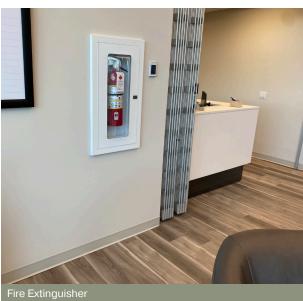
Fire Alarm Systems and Equipment

Current standard green "running man" signage is used throughout the facility. However, the fire extinguisher is mounted to high and the building lacks fire strobes in the washrooms and offices.

Item	Concern	Recommendation	Priority and Budget		
			Short Term	Mid Term	Long Term
1	Fire extinguisher is too high.	Lower fire extinguisher to no more than 1100 mm above floor.			\$1,500
2	No fire strobes in washrooms or offices.	Install visual and audible strobes in all locations where users or staff are likely to be alone.		\$5,000	
		\$0	\$5,000	\$1,500

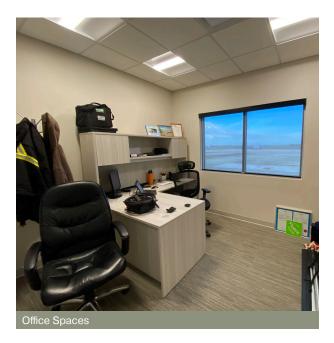
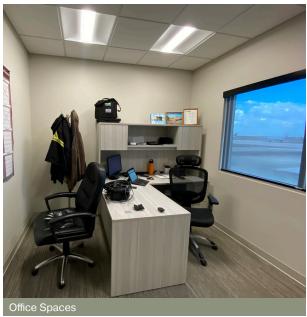
Office Spaces

The offices in the facility lack height adjustable desks.

Item	Concern	Recommendation	Priority and Budget		
			Short Term	Mid Term	Long Term
1	No height adjustable desks.	Provide height adjustable desks. Budget is per desk.		\$1,500	
		Sub-total	\$0	\$1,500	\$0

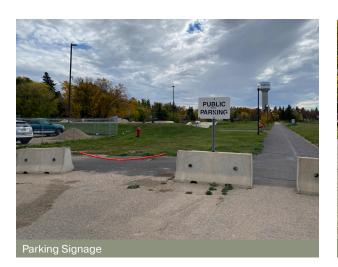
The parking lots for the Brodie Corridor are gravel and lack accessible stalls. Parking stalls also lack indication through painted lines or vertical signage. At the parking lot near the water tower, there is no accessible path to the paved pathway.

Item	Concern	Recommendation	Priority and Budget		
			Short Term	Mid Term	Long Term
1	Parking lots are gravel.	Pave parking lots.	\$95,000		
2	Parking lots lack accessible stalls.	Provide accessible stalls. Include 2 meter access aisle on at least one side of the stalls. Stall dimensions to meet or exceed CSA-B651-23. Include signage designating accessible stalls.	\$10,000

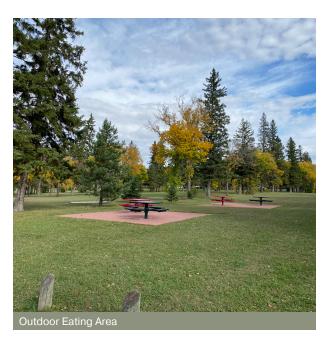
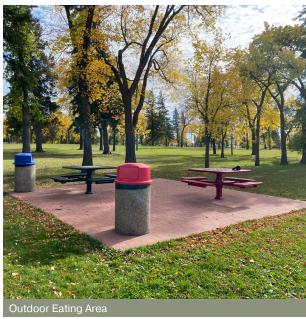
Outdoor Eating Areas

There is an area with tables and seating with chess tables, but they are not accessible and lack paving from the main pathway.

Item	Concern	Recommendation	Priority and Budget		
			Short Term	Mid Term	Long Term
1	No accessible / paved path to picnic / chess tables.	Provide designated accessible path to picnic / chess tables.		\$10,000	
2	No designated accessible seating at picnic / chess tables.	Provide accessible seating at picnic / chess tables.		\$2,500	
Sub-total			\$0	\$12,500	\$0

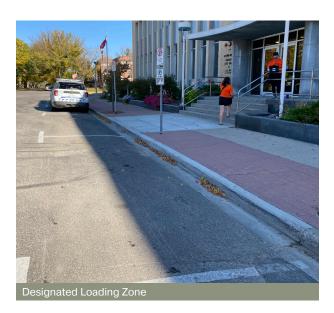
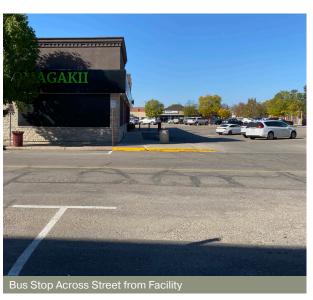
General Vehicular Access

The extent of the loading zone at the main entrance lacks curb cut and is unclear with arrows on signage that are misleading. The closest bus stop is across the street without seating or a shelter.

Item	Concern	Recommendation	Priority and Budget		
			Short Term	Mid Term	Long Term
1	Extent of loading zone is unclear. Arrows on signs are misleading.	Provide additional signage and colour-contrasted curbs at drop off area.	\$2,500		
2	Loading zone lacks curb cuts.	Provide curb cuts at loading zone, ensure they contrast with surroundings.	\$2,500		
3	Closest bus stop is across the street and lacks seating or shelter.	Provide designated path of travel to nearby bus stop and install shelter with seating below.		\$10,000	
	1	\$5,000	\$10,000	\$0

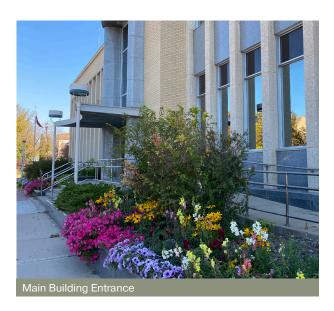
Building Entrances

The building has one main entrance that is easy to identify, has a canopy and has well-maintained planters. However, there is no seating provided underneath the canopy. At the entrance doors, the push button actuators are too small, only at one height, and are not interconnected. The outside door does not have a sufficient hold open time.

Inside the vestibule, the flooring at the door threshold is in disrepair and the contrast between the flooring and walls is insufficient.

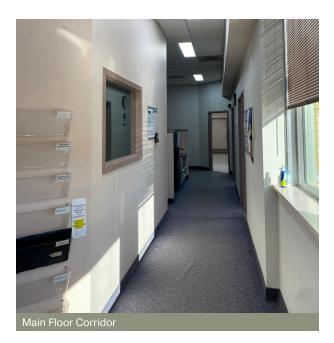
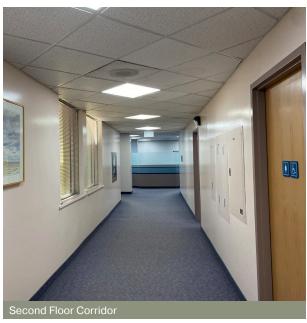
Corridors and Hallways

The corridors are typically appropriate in width, but the corridor to the area of refuge is too narrow.

Item	Concern	Recommendation	Priority and Budget		
			Short Term	Mid Term	Long Term
1	Corridor to area of refuge is too narrow.	Renovate corridors to ensure a minimum clear width of 1500 mm.			\$15,000
	Sub-total			\$0	\$15,000

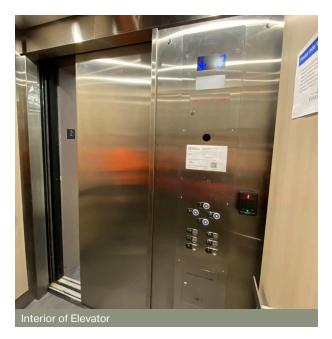
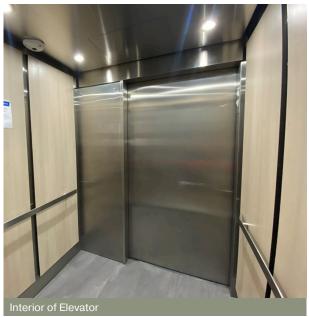
Elevators and Platform Lifts

There is one elevator in the city hall portion of the building. While the buttons light up when pressed, there is no audible confirmation. There are minimal handrails in the elevator and the doors do not have sufficient contrast with the cab finishes.

Item	Concern	Recommendation	Priority and Budget		
			Short Term	Mid Term	Long Term
1	Buttons light up when pressed but lack audible confirmation.	Modify buttons to provide audible feedback when pressed.		\$5,000	
2	Handrails are rectangular, non-accessible design.	Replace handrails with accessible design versions.	\$2,500		
3	Doors do not have sufficient contrast with cab finishes.	Revise door finish to have at least 70% contrast with elevator cab walls.			\$1,500
	·	Sub-total	\$2,500	\$5,000	\$1,500

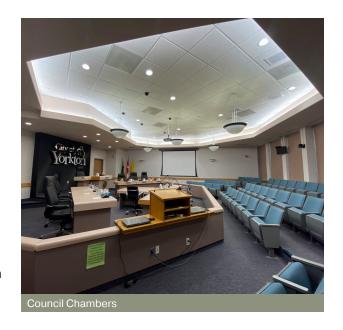
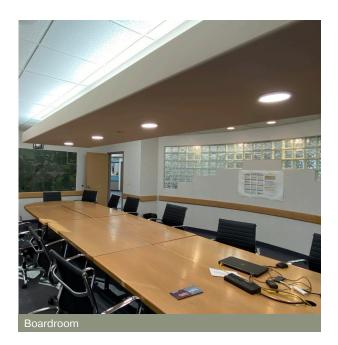
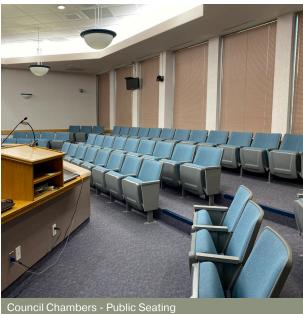
Waiting Areas, General Seating, Meeting Rooms, and Lounges

The council chamber generally lacks accessible design. There is no designated accessible seating at the council area or general seating. The speaking podium is too high, lacks height adjustability, and knee space. While there is one row of seating at the same floor level – the space in front is limited. At the council seating, all chairs have arms with the councilor and major seating is only accessible by steps.

In the second floor boardroom, the knee space at the coffee counter is too low. While there is ample room to move around in the space, the boardroom only has one option for seating.

Item	Concern	Recommendation	Pric	ority and Bud	lget
			Short Term	Mid Term	Long Term
1	Council counter is too high.	Replace counter with lower, accessible version, no more than 860 mm above floor.		\$10,000	
2	Council counter lacks knee space under sink.	Replace sink cabinet with version that has knee space. Knee space to be at least 685 mm high.		\$2,500	
3	Council fridge is freezer- on-top style.	Replace fridge with freezer-on-bottom style.			\$2,500
4	Only one row of seating in council chambers is at level height.	Demolish raised platforms in council chambers.	\$15,000		
5	No designated accessible seating spots in council chambers.	Provide designated accessible seating in council chambers.		\$2,500

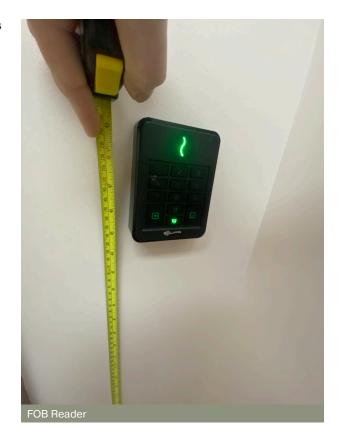
Acoustics, Illumination, and Building Systems

The thermostats, light switches, FOB readers, and keypads are generally too high throughout the building and would be difficult to reach for wheelchair users.

Item	Scope	Recommendation	Pric	Priority and Budget		
			Short Term	Mid Term	Long Term	
1	Thermostats are too high.	Lower thermostats to no more than 1100 mm above floor.			\$10,000	
2	Light switches are too high.	Lower light switches to no more than 1100 mm above floor.			\$10,000	
3	FOB readers are too high.	Lower FOB readers to no more than 1100 mm above floor.			\$5,000	
4	Keypads are too high.	Lower keypads to no more than 1100 mm above floor.			\$5,000	
		Sub-total	\$0	\$0	\$30,000

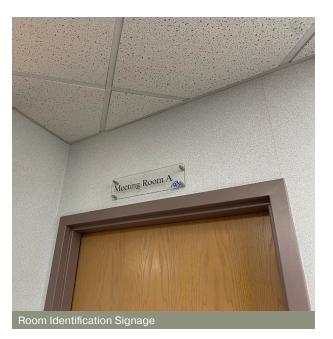
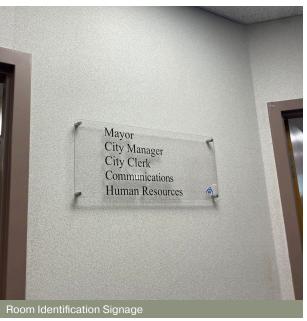
Room Identification Signage

The offices throughout the building generally do not have identification signage. The second level signage is glass which has glare. The signage also lacks tactile and braille components and is often located above or on doors.

Item	Concern	Recommendation	Prior	ity and Budo	get
			Short Term	Mid Term	Long Term
1	No room identification signage on offices.	Provide room identification signage where missing.	\$30,000		
2	Suite signage is glass with glare.	Replace signs with matte / non-glare versions.	\$2,500		
3	Suite signage lacks tactile and Braille components.	Replace with versions that have tactile and Braille components.	Included in Room Identification Sign item #2		
4	Signage is often located above or on doors and lacks tactile and Braille components.	Replace signs on / above doors with latch-side, wall mounted signs at 1500 mm. Signage to be high contrast, tactile, and include Braille.	\$30,000		
	•	\$62,500	\$0	\$0

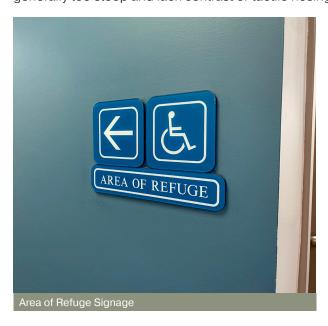
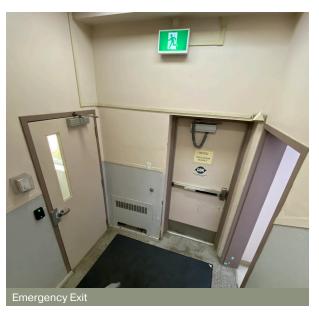
Emergency Exits and Areas of Refuge

The second floor has an area of refuge but the signage lacks tactile and braille components. All emergency exits require passage navigating exterior stairs. The interior emergency exit stairs are generally too steep and lack contrast or tactile nosings, which is typical of a building from this period.

Item	Concern	Recommendation	Priority and Budget		dget
			Short Term	Mid Term	Long Term
1	Area of refuge signage lacks tactile and Braille components.	Replace with version that has tactile and Braille.	\$1,500		
2	All emergency exits require navigating exterior stairs.	Replace exterior egress stairs with low slope ramps. Budget is per ramp.			\$15,000
3	All emergency exit stairs lack contrast and tactile nosings.	Install colour contrasted and tactile strips on nosing of stair treads.		\$2,500

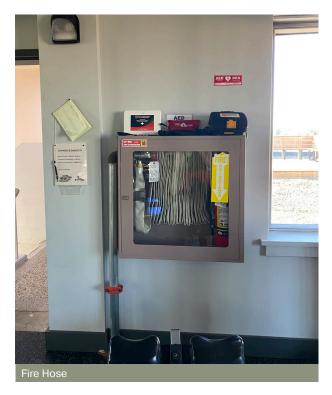
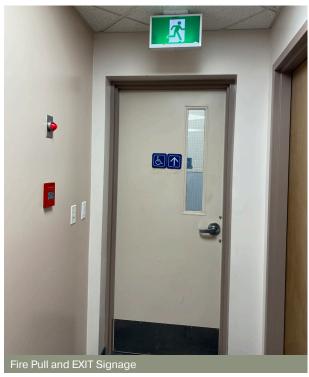
Fire Alarm Systems and Equipment

Yorkton City Hall has several fire strobes in the building. While there are AEDs in key areas and a first aid kit in the third floor gym, they are mounted too high in the gym and main lobby. The fire pulls throughout the building are also mounted too high. In the staff room, there is a fire extinguisher that is visually impeded by a vending machine.

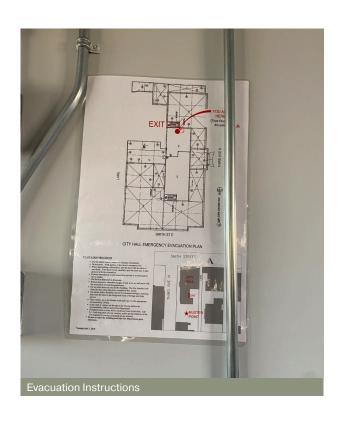
Evacuation Instructions

While this facility does have evacuation instructions posted, they are mounted very high, have glare, and are limited to one format only.

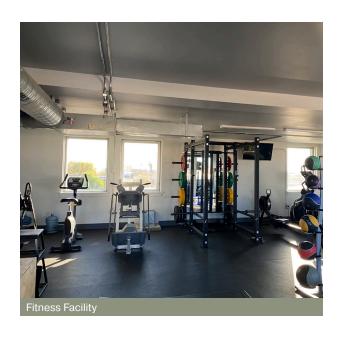
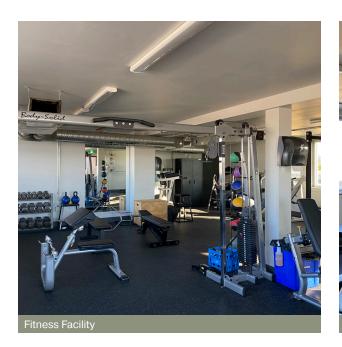
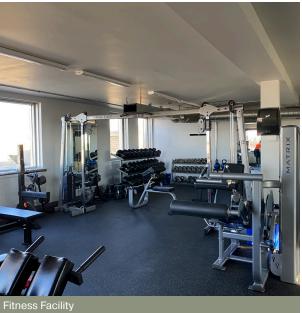
Fitness and Sports Facilities

There is a fitness facility located on the third floor of City Hall, but it is only accessible by stairs and lacks designated accessible equipment. The floor to wall contrast is insufficient with very dark flooring. The paper towel is also mounted too high throughout the room.

Item	Concern	Recommendation	Priority and Budget		
			Short Term	Mid Term	Long Term
1	No designated accessible equipment.	Provide a variety of equipment that can be modified to suit accessibility needs.		\$50,000	
2	Insufficient floor to wall contrast.	Paint / install wall base material that has at least 70% contrast with floor.			\$1,500
3	Paper towel is too high.	Lower paper towel to no more than 1100 mm above floor.	\$500		
4	Floor is dark.	Replace dark flooring with lighter colour.			\$15,000
Sub-total Sub-total			\$500	\$50,000	\$16,500

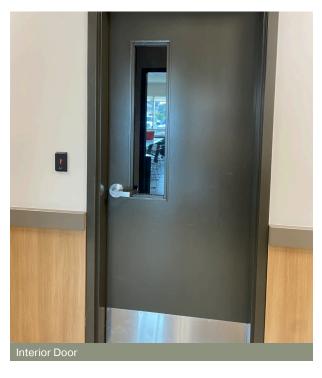
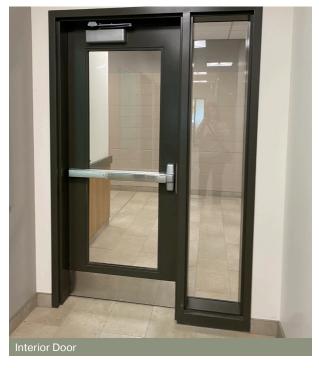
The doors throughout the building contrast well with the walls but are typically insufficient in clear width. Some doors have narrow lites provided for vision glazing and while it may have been to code at the time of construction, they are too high. Some doors in the building lack kickplates.

Item	Concern	Recommendation	Pric	ority and Bud	dget
			Short Term	Mid Term	Long Term
1	Doors lack sufficient clear width.	Replace single leaf doors with 1000 mm wide doors, minimum. Ensure vision glazing, accessible hardware, and kickplates are included. Budget assumes 50 doors.			\$150,000
2	Where vision glazing narrow lites are provided, they are too high.	Expand glazing in doors. Bottom of glazing to be no more than 900 mm above floor. Budget assume 20 doors.		\$30,000	
3	No kickplates on a few doors.	Provide kickplates on interior doors, where missing. Budget assumes 10 doors.	\$5,000		
	•	\$5,000	\$30,000	\$150,000

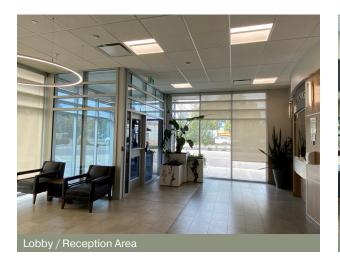
The lobby is spacious with room to maneuver. There is only one type of seating provided and the floor colour carries up the wall.

Item	Concern	Recommendation	Priority and Budget		
			Short Term	Mid Term	Long Term
1	Only one type of seating available.	Replace seating to ensure a mix of chairs with and without arms.			\$10,000
2	Floor colour carries up the wall.	Paint walls or install wall materials to ensure 70% contrast with floors.			\$1,500
		\$0	\$0	\$11,500

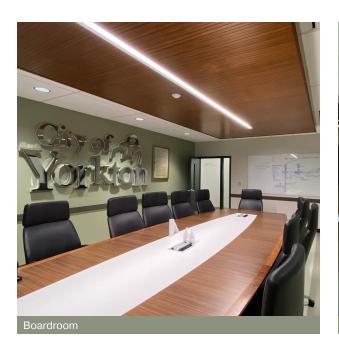
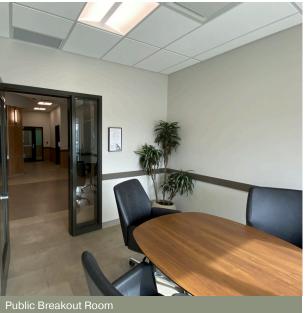
In the public breakout room, the floor colour carries up the wall which prevents contrast.

Item	Concern	Recommendation	Priority and Budget		
			Short Term	Mid Term	Long Term
1	Counters are too high.	Replace millwork to accommodate lower counter. Top of counter to be no more than 860 mm above finished floor.		\$25,000	
2	No knee space at counter.	Replace millwork with version that has knee space. Knee space to be at least 685 mm high.		\$2,500	
3	Floor colour carries up wall in public breakout room.	Install wall base materials to ensure 70% contrast with floors.			\$1,500
		\$0	\$27,500	\$1,500

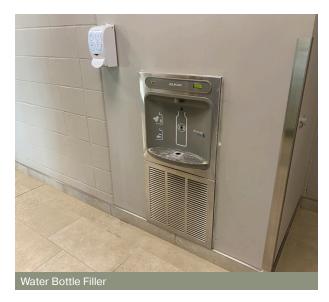
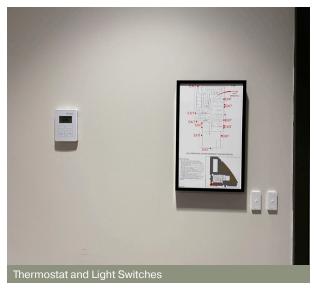
The thermostats and the FOB readers are typically too high throughout. At the main reception desk, there is a door control button that is also mounted too high.

Item	Scope	Recommendation	Priority and Budget		
			Short Term	Mid Term	Long Term
1	Thermostats are too high.	Lower thermostats to be no more than 1100 m above floor.			\$5,000
2	FOB readers are too high.	Lower FOB readers to be no more than 1100 mm above floor.			\$2,000
3	Door control button in reception is too high.	Lower door control button to no more than 1100 mm above floor.			\$1,500
	•	\$0	\$0	\$8,500

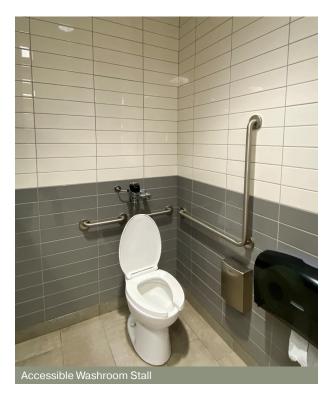
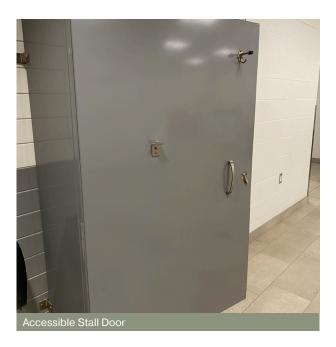
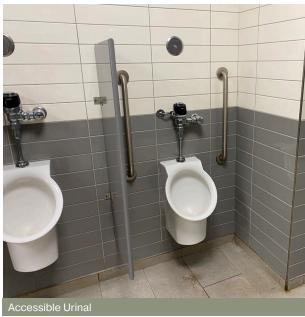
There are accessible cubicles in the admin area and within the change room washrooms. In the change room washrooms, a good transfer space is provided in the accessible stall and a fire strobe is provided. Typically, there are several elements mounted too high and some accessories for accessibility are missing.

The washrooms generally lack contrast between the floor and wall. The washroom doors have good contrast to the wall and have kickplates.

There is large scale signage used to identify washrooms near the administrative area, but they lack clarity from further down the hall (as a blade signage type). In the men's accessible washroom, there is a urinal with grab bars but it is mounted too high.

Item	Concern	Recommendation	Priority and Budget		
			Short Term	Mid Term	Long Term
1	Counters / sinks are too high. (Change Rooms and Admin)	Replace counter with lower, accessible version, no more than 860 mm above floor. Ensure knee space under sink to be at least 685 mm high.		\$20,000	
2	Mirrors are too high. (Change Rooms and Admin)	Lower height of mirror to no more than 1000 mm above floor from bottom of the mirror.	\$4,000		
3	Paper towel is too high. (Change Rooms and Admin)	Lower paper towel to be no more than 1100 mm above floor.	\$500		
4	Insufficient contrast between floor and wall. (Change Rooms and Admin)	Paint walls / install wall base material to have at least 70% contrast with floors.			\$2,500

Sub-total	\$24,500	\$86,000	\$2,500
12	Insufficient identifying signage. (Admin)	Add more signage for room. Signage to be high contrast, tactile, and include Braille. Mount at 1500 mm on the latch side of doors / openings.	\$1,500		
11	Insufficient transfer space beside toilet. (Admin)	Renovate washroom area to expand clear transfer space to 1000 mm minimum.		\$60,000	
10	Men's urinal is too high. (Change Rooms and Admin)	Lower urinal to accessible height.	\$2,500		
9	No occupancy indicators. (Change Rooms and Admin)	Replace cubicle door hardware with version that has occupancy indicators.	\$3,000		
8	Coat hooks are located on the back of cubicle doors and are mounted too high. (Change Rooms and Admin)	Install coat hooks no more than 1100 mm above floor and ensure coat hooks are on walls and not the backs of stall doors.	\$500		
7	No backrest on toilets. (Change Rooms and Admin)	Install back supports on toilets where a tank is not present.		\$6,000

6	Back grab bar is not continuous. (Change Rooms and Admin)	Replace with a continuous grab bar.	\$12,000		
5	Toilet paper too far from toilet. (Change Rooms and Admin)	Move toilet paper dispenser closer to toilet.	\$500

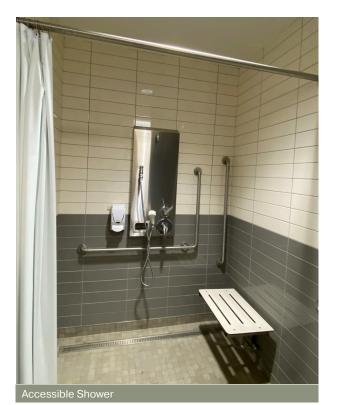
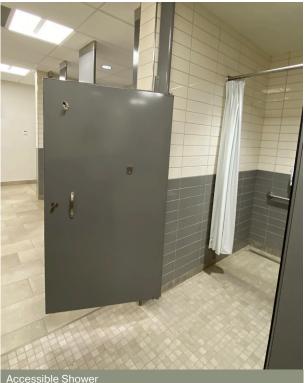
There are showers provided in the change rooms with an accessible stall available in each. The showers are zero-entry making them easier to access. However, the coat hooks are mounted too high and are located on the back of the stall doors. Additionally, the shower head is not adjustable and there is insufficient floor to wall contrast.

Item	Concern	Recommendation	Priority and Budget			
			Short Term	Mid Term	Long Term	
1	Insufficient floor to wall contrast.	Paint walls / install wall base material to have at least 70% contrast with floors.			\$1,500	
2	No height adjustable shower head.	Revise shower head to height adjustable version.	\$2,500			
3	No occupancy indicators.	Replace cubicle door hardware with version that has occupancy indicators.	\$1,500

4	Coat hooks are on the back of the door and mounted too high.	Install coat hooks no more than 1100 mm above floor and ensure coat hooks are on walls and not the backs of stall doors.	\$500		
5	Missing grab bars.	Install additional horizontal grab bar on wall opposite fold down seat. Install additional vertical grab bar on wall with fold down seat at shower threshold.	\$6,000		
	Sub-total			\$0	\$1,500

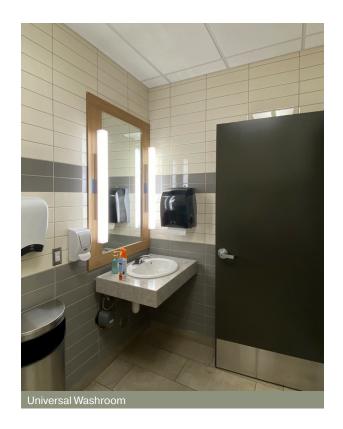
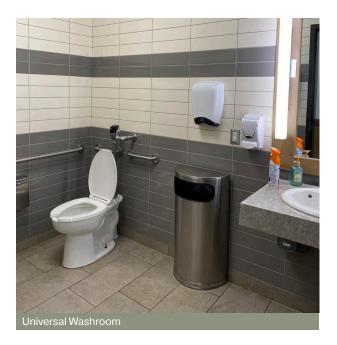
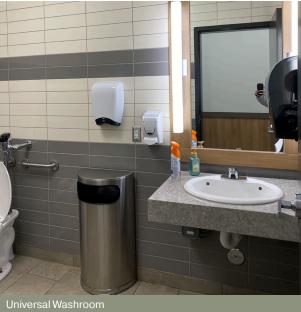
While there is a universal washroom located in the main lobby that may have met code for accessibility at the time of construction, it lacks several features for the current standard of accessibility.

Item	Concern	Recommendation	Pric	ority and Bud	daet
10111	Consorn	1000mmonauton	Short Term	Mid Term	Long Term
1	Back grab bar is not continuous.	Replace with a continuous grab bar.	\$3,000		
2	No backrest on toilet.	Install back support on toilet where a tank is not present.		\$1,500	
3	Toilet paper too far from toilet.	Move toilet paper dispenser closer to toilet.	\$500		
4	Transfer space impeded by garbage.	Relocate garbage to ensure clear transfer space.	\$250		
5	Coat hook, paper towel, and mirror is too high.	Lower coat hooks and paper towel to no more than 1100 mm above floor. Lower height of mirror to no more than 1000 mm above floor from bottom of mirror.	\$1,500

6	Sink / counter is too high.	Replace counter with lower, accessible version, no more than 860 mm above floor. Ensure knee space under sink to be at least 685 mm high.		\$5,000	
7	No outlets by toilet or sink. No emergency button by toilet.	Install power outlets near toilet and sink.			\$4,000
8	No door actuator push buttons provided at universal washroom doors.	Install door actuator control push button. Push button to be elongated actuator that can be activated from 400 mm to 1100 mm above floor on both sides of door. Budget is per door.	\$2,500		
9	No adult change table provided.	Install height-adjustable adult change table.	\$50,000		
10	No occupancy indicators.	Replace door hardware with version that has occupancy indicators.	\$1,500		
11	Insufficient identifying signage.	Add more signage for room. Signage to be high contrast, tactile, and include Braille. Mount at 1500 mm on the latch side of the door.	\$750

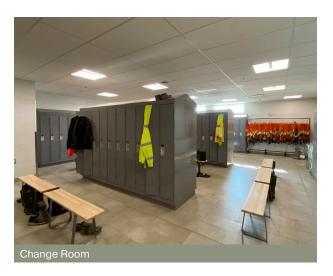
The change rooms have ample space but only have full-height lockers provided. There are several benches, but there are no options with arms or backs for seating.

Item	Concern	Recommendation	Priority and Budget		
			Short Term	Mid Term	Long Term
1	Only full height lockers provided.	Provide at least 50% lower height lockers.		\$10,000	
2	No options for arms or backs on benches.	Provide a variety of seating, backless, with back, armless, and with arms.			\$5,000
	<u> </u>	Sub-total	\$0	\$10,000	\$5,000

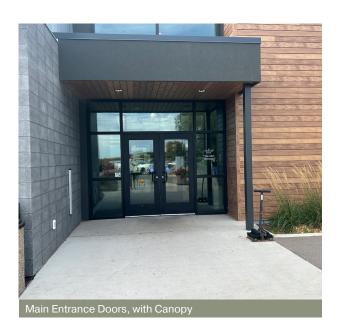
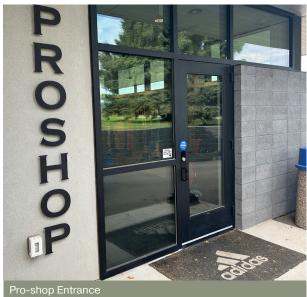
The building has three main entrances. The primary main entrance is easily distinguishable with landscaping and architectural features flanking it. The main building entrance also includes a canopy which further helps distinguish it as an entrance. The secondary entrances are located at back of the building for access from the golf course and tucked along the front façade is the Pro Shop main entrance. All doors lack sufficient contrast with the adjacent glazed walls. Multilevel push button actuators are used but some have impeded access or are located too high.

Danaing Entraneous								
Item	Concern	Recommendation	Prid	dget				
			Short Term	Mid Term	Long Term			
1	No seating provided.	Install seating at main entrance.		\$2,500				
2	No edge protection where pedestrian paths drop to gravel.	Provide edge protection or tactile warning in areas where path drops to gravel.		\$2,500

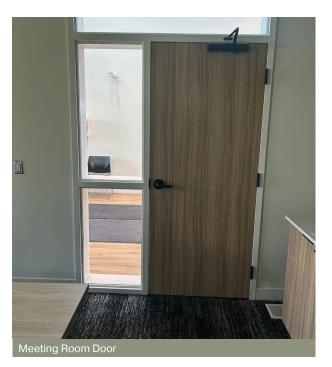
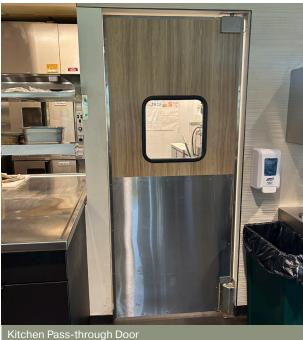
Interior doors and doorways within the Clubhouse have good contrast with surroundings and use sufficient hardware. However, washroom and meeting room doors are an insufficient width.

Item	Concern	Recommendation	Pric	rity and Bud	dget
			Short Term	Mid Term	Long Term
1	Meeting room and office doors have an insufficient width.	Replace single leaf doors with 1000 mm wide doors, minimum. Ensure vision glazing, accessible hardware, and kickplates are included. Budget assumes 5 doors.			\$15,000
2	Meeting room doors are heavy.	Adjust door to require less force to open. Budget assumes 2 doors. Interior doors to require no more than 22 N of force.	\$500		
3	Pro-Shop interior door handle is too high.	Lower handles on door. Centre of handle to be located no more than 1100 mm above floor. Budget assumes 2 doors.	\$1,000

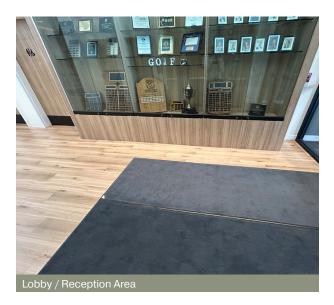
The Deer Park Clubhouse has a central lobby space connected to the main building entrance and the Golf Course entrance. While there is good contrast between the floors and the walls, there is a lack of contrast between the floors and the cabinetry. Additionally, black mat is laid out throughout the lobby space and the visitor sign in counter is too high and only at one height. There is no seating provided within the lobby space.

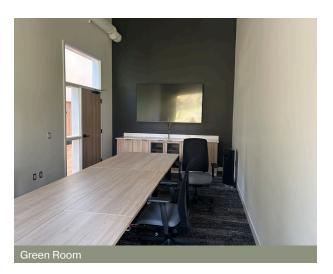
There is one meeting room – the Green Room – located in the Clubhouse directly off the lobby and restaurant. The room provides only one type of seating, and the counters are too high and lack knee space. Cabinet hardware is also insufficient as they utilize flat edge pulls that require dexterity to use.

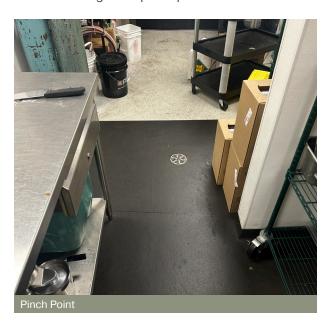
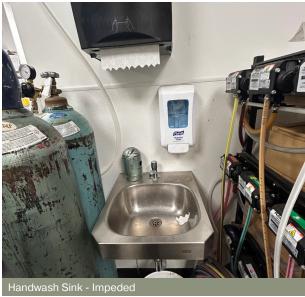
The Deer Park Clubhouse has a restaurant with a commercial kitchen that serves the dining area, along with a Snack Shack that is accessed from the exterior of the building. The kitchen lacks accessible features for receiving, serving and preparing food. Many of the counters, fixtures, and equipment are located too high and pinch points are created between walls and workspaces.

Item	Concern	Recommendation	Priority and Budget		
			Short Term	Mid Term	Long Term
1	Counters in kitchen are not at accessible height.	Replace counter with lower, accessible version, no more than 860 mm above floor. Ensure knee space under sink and additional knee space for working.		\$10,000

2	No knee space under dishwashing sinks.	Replace sinks with version that has knee space. Knee space to be at least 685 mm high.		\$2,500

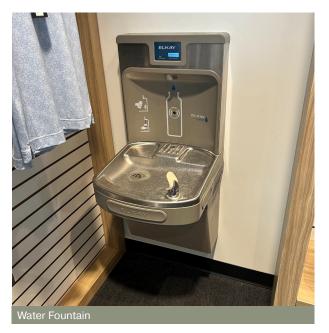
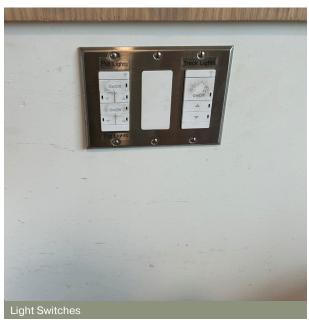
The outdoor seating area within the restaurant has ceiling fans that create a strobing effect when the above lights are turned on.

Item	Scope	Recommendation	Priority and Budget		
			Short Term	Mid Term	Long Term
1	Thermostats are too high.	Lower thermostats to no more than 1100 mm above floor.			\$5,000
2	Light switches are too high.	Lower switches to no more than 1100 mm above floor.			\$5,000
3	Security panel is too high.	Lower security panel to no more than 1100 mm above floor.			\$1,000
4	Water fountain has impeded access by merchandise.	Relocate merchandise to ensure clear access to fountain.	\$250		
5	Ceiling fans create strobe effects in patio dining space.	Adjust spacing of lights to minimize strobe effect.			\$15,000
		\$250	\$0	\$26,000

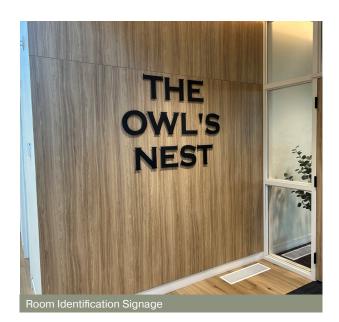
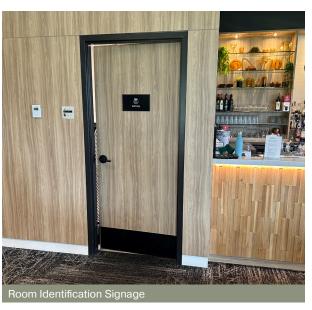
Room identification signage is utilized throughout the Deer Park Clubhouse; however, some signage is located on doors and there are no alternative formats provided.

Room Identification Signage Item Concern Recommendation Priority and Budget							
iteiii	Concern	recommendation	FIIOI	ity and budg	Jei			
			Short Term	Mid Term	Long Term			
1	Most signage is located on doors.	Replace signs on doors with latch-side, wall mounted signs at 1500 mm. Signage to be high contrast, tactile, and include Braille.	\$10,000					
2	Lack of tactile and Braille components.	Replace signs with signage that has tactile and Braille.	Included in Room Identification Signage item #1.					
3	Some rooms lack signage.	Provide room identification signage where missing.		\$2,500				
		Sub-total	\$10,000	\$2,500	\$0

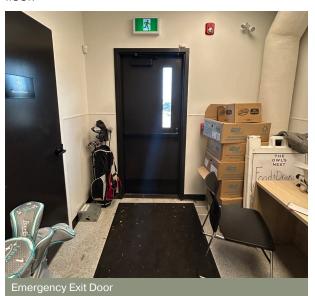
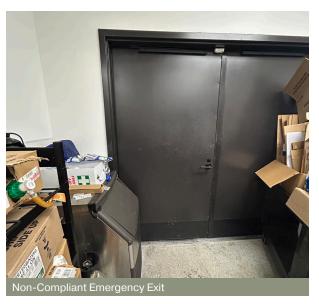
The Deer Park Clubhouse has generally sufficient emergency exits which all lead out to even and smooth surfaces. One of the kitchen emergency exits does not have a push bar and is slightly impeded as the adjacent space is being used for storage and the other kitchen emergency exit has black mats on the floor.

Item	Concern	Recommendation	Priority and Budget		
			Short Term	Mid Term	Long Term
1	Kitchen emergency exit lacks a push bar, is partially impeded by storage items and has a deadbolt.	Replace hardware with crash bar or easier to use version. Remove storage items blocking exit and remove deadbolt to ensure easy exit.	\$1,500		
2	Kitchen and kitchen office emergency exits have black mat on floor.	Replace mat with lighter colour version.	\$1,500		
		Sub-total	\$3,000	\$0	\$0

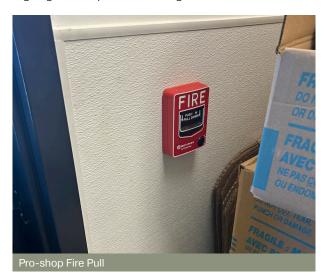
There are fire alarm pulls, extinguishers, AEDs and strobes dispersed throughout the facility. Fire alarm pulls, AEDs and extinguishers are mounted too high and the extinguishers and AEDs should have blade signage to help with locating them.

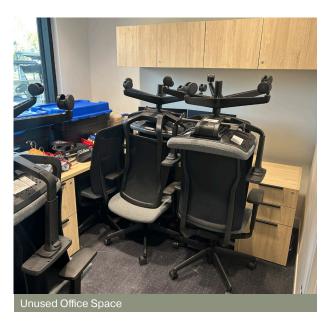
There are five office spaces within the Clubhouse. Two are located directly off the lobby and are currently not being used, one is located within the Pro Shop, and the last two are located within the restaurant. None of the desks are height adjustable and only one type of seating option is provided.

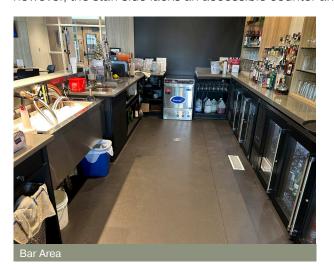
Cafeterias, Restaurants, and Bars

The Deer Park Clubhouse has a restaurant and bar that serves the golf course and general public. Within the dining area there are multiple areas for sitting along with different seating options available; however, no designated accessible seating is provided. The bar is intended for preparation of drinks only; however, the staff side lacks an accessible counter and the knee space under the till is insufficient width.

Garotorii	Caleterias, Nestaurants, and Dais							
Item	Concern	Recommendation	Priority and Budget					
			Short Term	Mid Term	Long Term			
1	Paper towel is too high in bar.	Lower paper towel to be no more than 1100 mm above floor.	\$500					
2	Knee space under POS is an insufficient width.	Replace millwork to accommodate 800 mm wide knee space at POS.		\$10,000				
3	Cabinet hardware style insufficient in bar.	Replace hardware with D pull style, ensure new hardware is contrasting colour.	\$1,500					
4	Lack of contrast between floors and cabinets in bar.	Refinish cabinets to provide contrast with floors.			\$5,000

5	Serving window requires dexterity to operate.	Modify or replace hardware to be easy-to-	\$1,500		
6	Serving counter at snack shack is too high.	Replace counter with lower, accessible version, no more than 860 mm above floor.			\$10,000
7	Bar only has higher height of counter, no accessible height area provided.	Provide accessible height counter, centred on bar counter. Ensure accessible portion has sufficient knee space.	\$5,000		
8	Narrow space behind snack shack serving counter.	Renovate to provide wider corridor behind counter.			\$10,000
9	Lack of contrast between floors and fireplace.	Provide visual contrast strip at base of fireplace / edge of floor.		\$2,500	
10	Only one height of podium.	Provide a height adjustable podium.	\$1,500		
11	No designated accessible seating.	Provided designated accessible seating areas.		\$2,500	
12	Glazing / screening around 3 season seating lacks sufficient visual contrast.	Add colour-contrasting strips on full width of glazing. Strips to be installed between 1350 and 1500 mm above floor.	\$1,500

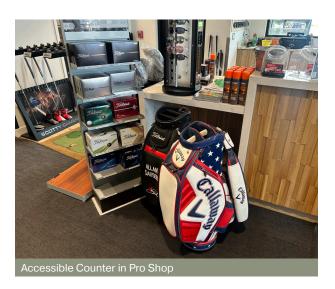
The Deer Park Clubhouse has a Pro Shop that sells golf related merchandise. There is an accessible service counter at the tills; however, it is being used as additional shelving for products and the staff side does not have a sufficient knee clearance depth. Prices for products are not clearly displayed, and golf course and rental fees are not displayed. There is also a fitting room within the Pro Shop, but it is being used for storage purposes.

Item	Concern	Recommendation	Pric	ority and Bud	lget
			Short Term	Mid Term	Long Term
1	Accessible counter access impeded.	Remove / relocate items impeding access to ensure clear access space.	\$250		
2	Accessible counter knee clearance depth insufficient.	Replace counter with one that has sufficiently deep knee space.	\$5,000		
3	Staff accessible counter has insufficient depth.	Replace counter with one that has sufficiently deep knee space.	Included in Retail Outlets item #2		
4	Cabinet drawer hardware insufficient.	Replace hardware with D pull style, ensure new hardware is contrasting colour.	\$1,500		
5	Lack of contrast between floors and walls in merchandise spaces.	Paint / install wall base material to ensure at least 70% contrast with floors.			\$1,500

6	Prices are not clearly displayed; users are required to move items to determine pricing.	Provide clear and easy-to- read pricing for all items.		\$1,500	
7	Golf course fees and rental fees are not displayed.	Provide clear and easy-to- read fees for all items.		\$1,500	
8	Pro-Shop has dark and busy floor mats.	Replace mats with simple, non-busy and lighter colour version. Ensure mats have sufficient contrast from wall.	\$1,500		
9	Fitting room bench lacks arms.	Provide option for arms fitting room benches.			\$2,500
		\$8,250	\$3,000	\$4,000

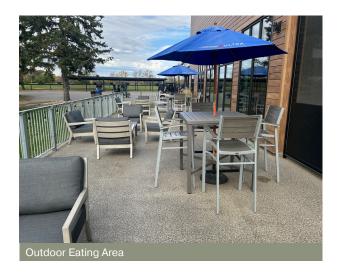
The Deer Park Clubhouse has an outdoor patio and eating area adjacent to the restaurant. While there are multiple types or seatings and table heights available, there are no armless seating options available. The railing surrounds the patio also lacks a toe kickplate.

Item	Concern	Recommendation	Priority and Budget		
			Short Term	Mid Term	Long Term
1	Lack of contrast between floor and exterior wall.	Refinish door to provide visual contrast with adjacent wall.			\$5,000
2	No kickplates at railing.	Install toe-kick guard at railing.	\$1,500		
3	No armless seating options available.	Provide armless seating options adjacent armed options.			\$2,500
4	No designated accessible seating.	Provided designated accessible seating areas for outdoor eating area.		\$2,500	
		\$1,500	\$2,500	\$7,500

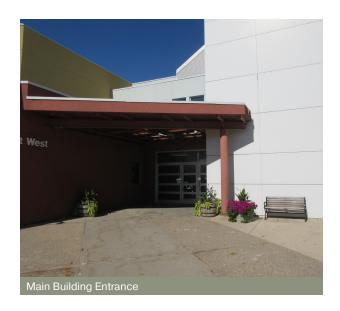
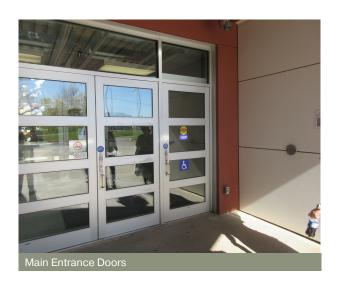
Building Entrances

The building has two public entrances. The main entrance at the south of the building is easy to identify, has a canopy, and has well-maintained planters and landscaping. While seating is provided at the entry, there is none provided under the canopy. The east building entrance is harder to identify and does not have a canopy. At the main entrance doors, the push button actuator is too small and only at one height, but they are interconnected. At the east building entrance the push button actuator is at multiple levels.

Inside the vestibule, the contrast between the flooring and walls is insufficient and there is a black mat on the floor.

Item	Concern	Recommendation	Priority and Budget		
			Short Term	Mid Term	Long Term
1	Glazed doors lack sufficient visual contrast. [Main Entrance].	Add colour-contrasting strips on full width of door glazing.	\$1,500		
2	Doors lack sufficient contrast from adjacent glazed walls. [Main Entrance].	Refinish doors to provide visual contrast from adjacent walls.			\$5,000
3	Only one height of push button door actuator provided. [Main Entrance].	Revise door actuator control push button to be elongated actuator that can be activated from 400 mm to 1100 mm above ground on both sides of door.	\$2,500		
4	Entrance vestibule lacks sufficient contrast between floor and wall. [Main Entrance].	Paint / install wall base material to ensure at least 70% contrast with floors.			\$1,500

6	Seating provided, but not below entrance canopy [Main Entrance].	Relocate seating to be below entrance canopy.		\$1,500	
5	Entrance vestibule has black mat on floor. [Main Entrance].	Replace mat with lighter colour version.	\$1,500

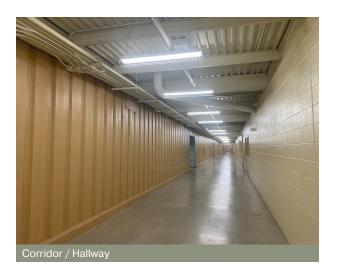
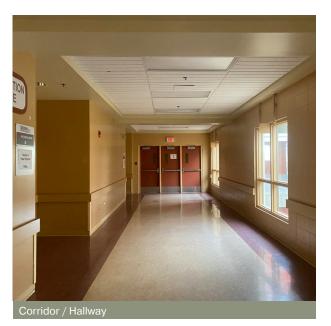
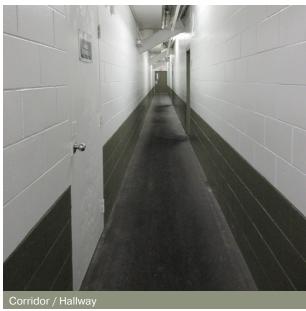
Corridors and Hallways

Corridors in the Gallagher center are sufficiently wide enough and allow for a logical and direct facility layout. Corridors have contrasting patterns and colours within the floor and do not have enough contrast between the floors and the walls.

Item	Concern	Recommendation	Priority and Budget		
			Short Term	Mid Term	Long Term
1	Corridors and hallways lack sufficient contrast between floors and walls.	Paint / install wall base materials to ensure at least 70% contrast with floors.			\$2,500
2	Benches provided in pool corridor lack option for arms.	Provide armed options adjacent armless options.			\$2,500
Sub-total			\$0	\$0	\$5,000

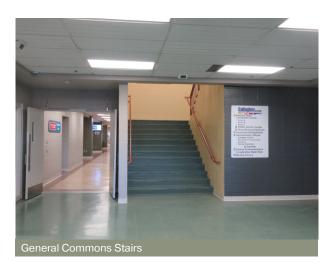
There are three feature interior stairs at the Gallagher Centre that are easily located. However, they lack many accessibilities features making ease of use more difficult for a variety of users.

Item	Concern	Recommendation	Priority and Budget		
			Short Term	Mid Term	Long Term
1	Stairs lack TAIs on landings.	Add TAIs to top landing and intermediate landing of stairs.		\$5,000	
2	Stairs lack tactile strips and contrast on nosings.	Provide contrast and tactile strips on stair nosings.		\$2,500

\$8,000	\$12,500	\$86,500	
8	No intermediate handrail at east entry stairwell.	Provide intermediate, continuous handrail.	\$2,500		
7	Landing at the top of the lobby feature stair is high gloss and slippery.	Replace flooring with a non-glare/matte, slip-resistant version.		\$5,000	
6	Lobby feature stair lacks toe kick protection at the landing.	Install toe-kick guard at landing.			\$1,500
5	Lobby feature stair has insufficient clear width.	Rebuild stairs to have at least 1200 mm clear width.			\$75,000
4	Lobby feature stair impedes head clearances.	Provide cane detectable warning rails where head clearance is less than 2050 mm. [Short Term] Enclose area under stairs where head clearance is less than 2050 mm. [Long Term]	\$3,000		\$10,000
3	Feature stairs only have one continuous handrail.	Provide additional continuous handrail on opposite side of stairs.	\$2,500

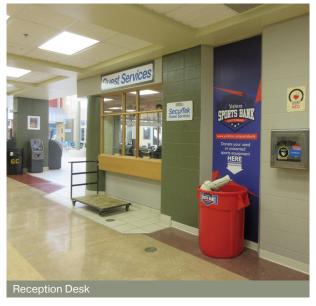
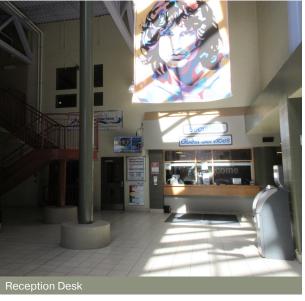
Reception Desks, Service Counters, and Self-Service Transaction Kiosks

Reception desks are located directly off the main building entrance. While it is a straight path from the entrance to the desk, there is a lack of contrast between the desk and the surroundings. The service counter is only provided at one height and lacks knee space. Additionally, the staff side has desks that are too high and lack adjustability.

Item	Concern	Recommendation	Priority and Budget		
			Short Term	Mid Term	Long Term
1	Counter lacks sufficient contrast with surroundings.	Replace counter with version that has at least 70% contrast with surroundings.	Included in Reception Desks item #2		
2	No lower height counter provided.	Provide accessible height counter, centred on reception desk counter. Ensure accessible portion has sufficient knee space.	\$10,000		
3	Lacks height adjustability on staff side.	Provide multiple height options or height adjustable desk for staff.	Included in Reception Desks item #2		
4	Counters too high on staff side.	Provide multiple height options or height adjustable desk for staff.		\$10,000	
5	Counter lacks lower height and knee space in the administration reception.	Provide accessible height counter, centred on reception desk counter. Ensure accessible portion has sufficient knee space.		\$2,500

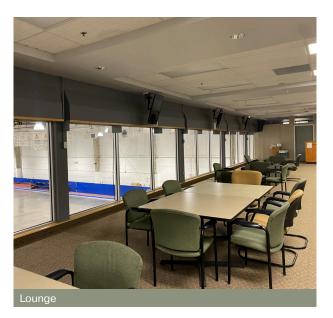
Waiting Areas, General Seating, Meeting Rooms, and Lounges

There are multiple general seating areas, meeting rooms and lounges in the Gallagher Centre for the various spaces and activities within the facility. Many of these areas only have one type of seating option available. Additionally, many of the counters and fixtures are located too high in these spaces.

Item	Concern	Recommendation	Priority and Budget		
			Short Term	Mid Term	Long Term
1	Freezer-on-top style of fridge throughout.	Replace fridges with freezer-on-bottom style. Budget is per fridge.			\$2,500
2	Pool meeting room soap is too high.	Lower soap to be no more than 1100 mm above floor.	\$500		
3	Pool meeting room, Ravine meeting room, and Administration boardroom counters are too high and lack knee space under the sink.	Replace counter with lower, accessible version, no more than 860 mm above floor. Ensure knee space under sink.		\$30,000	
4	Cabinets lacks sufficient contrast with hardware.	Replace hardware with versions that have at least 70% contrast with cabinets.	\$1,500

12	Sports Lounge televisions impede head clearances.	Provide cane detectable warning rails where head clearance is less than 2050 mm.	\$3,000		
13	Sports Lounge counter only at one height.	Provide accessible height counter, centred on counter. Ensure accessible portion has sufficient knee space.		\$10,000	
14	Sports Lounge lacks contrast on glass walls.	Add colour-contrasting strips on full width of glazing.	\$1,500		
15	Convention Centre floor has high contrast patterns throughout.	Replace flooring with simple design version, ensure new flooring has at least 70% contrast with surroundings.			\$25,000

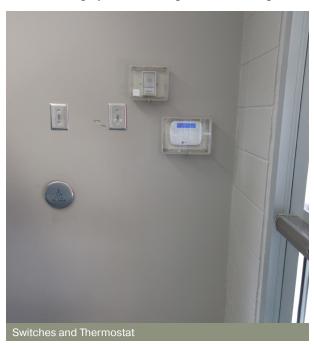
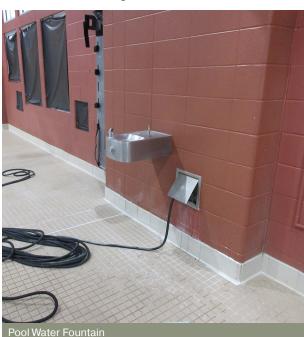
Acoustics, Illumination, and Building Systems

Most building systems throughout the Gallagher Centre are located too high.

Item	Scope	Recommendation	Priority and Budget		
			Short Term	Mid Term	Long Term
1	Light switches are too high and require dexterity to use.	Lower light switches to no more than 1100 mm above floor. Replace switches with easy-to-use rockers.			\$10,000
2	Thermostats are too high.	Lower thermostats to no more than 1100 mm above floor.			\$10,000

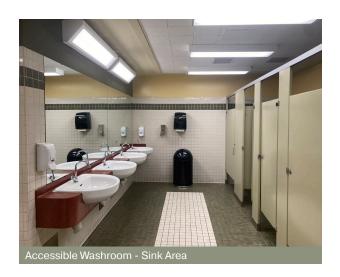
Accessible Washrooms

Accessible washrooms are located off the lobby and general seating areas. There are additional accessible washrooms found in the Flexihall and pool changing rooms. Adjustments to these washrooms are required for them to comply with accessibility guidelines.

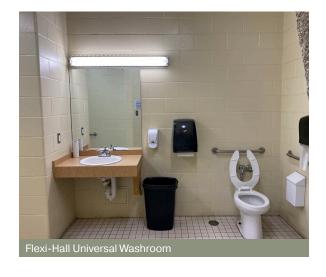
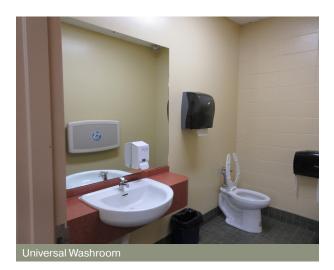
Universal Washrooms

The Gallagher Centre has two universal washrooms provided and one more in development within the aquatics facility. Additionally, the Flexihall has one universal washroom. Only one of the universal washrooms is currently equipped with an adult change table. All washrooms have insufficient or impeded transfer space and are not equipped with an emergency call button or outlet by the toilet.

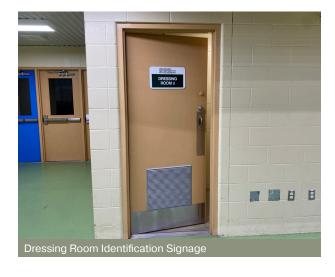
Room identification signage is utilized throughout the Gallagher Centre; however, signage is located on doors and does not have alternative formats. Additionally, there is a lack of signage denoting the accessible washrooms, showers and changerooms in the facility.

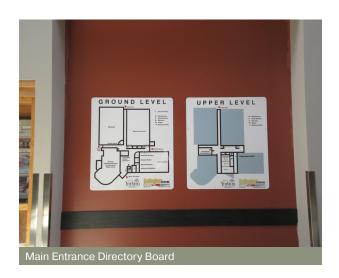
Directory Boards and Information Kiosks

There is a single directory board located at the main building entrance. It provides a general overview of the rooms located on the ground level and upper level.

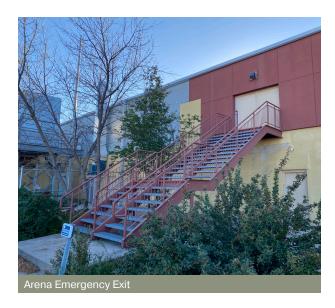
The Gallagher Centre has multiple emergency exit thresholds that are uneven with the outdoor pavement and require a step down. Emergency exits from the curling rink all have smooth transitions onto even concrete surfaces.

An area of refuge is noted within the aquatics facility with signage; however, it is unclear where the sign is referring too.

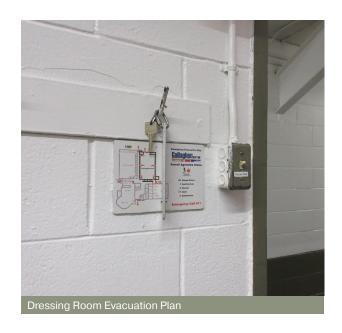
Evacuation Instructions

There are evacuation instructions located throughout the facility. These instructions are only presented in one format and are difficult to read.

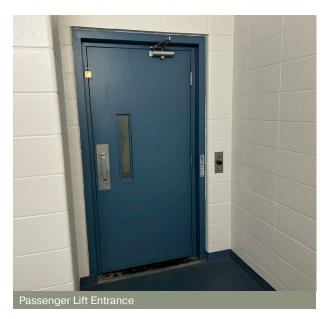
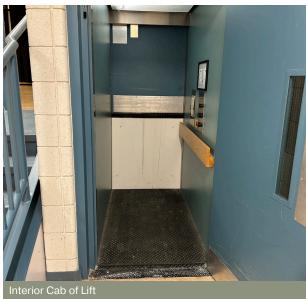
Elevators and Platform Lifts

There is one passenger lift in the Gloria Hayden Community Centre that provides access to the walking track; however, it lacks many features that would make it accessible. The lift does not have sufficient width, requires an attendant to operate and is not an enclosed space. It also lacks contrast, handrails, signage and is overall insufficient.

Item	Concern	Recommendation	Pric	Priority and Budget		
			Short Term	Mid Term	Long Term	
1	Buttons do not light up when pressed and lack audible confirmation.	Modify elevator buttons to light up and provide audible confirmation when pressed.		\$5,000		
2	No audible indication of travel direction or floor arrival.	Modify elevator to provide audible indication of travel direction and floor arrival.		\$10,000		
3	Call button lacks signage.	Provide signage for call button.	\$1,500			
4	No handrails.	Install handrails that meet or exceed CSA-B651-23.	\$2,500			
5	Lift has insufficient width.	Upgrade lift to larger elevator.			Included in Elevators item #9.	
6	Lift has insufficient contrast between floors and walls.	Modify wall finish material to ensure at least 70% contrast with floors.			\$1,500

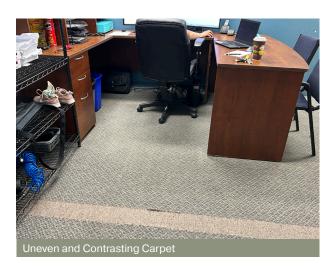
Office Spaces

The Gloria Hayden Community Centre has one office directly off of the lobby. A floor patch where a previous was used to be has created uneven and contrasting floors. No height adjustable desks is available and only one type of seating is provided.

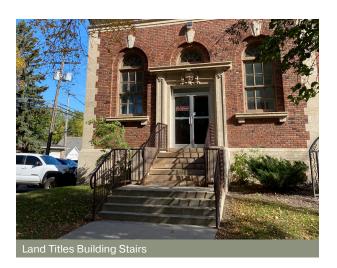
Exterior Stairs

There are exterior stairs located at the Land Titles entrance which have an inconsistent rise/run, with the tread depth too short. The treads also lack TAIs as well as tactile and contrast nosings. The handrail is not an accessible design with its square profile and lack of continuity.

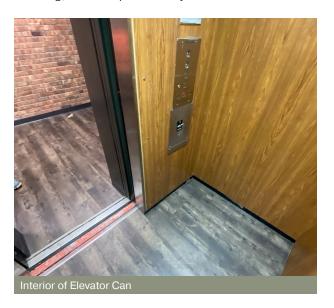
The elevator is quite far from the accessible entrance and lacks several accessibility features such as railings, audible indication of floors, Braille on buttons, etc. There is a lift at the stairs in the Land Titles building, but it requires a key to use.

Item	Concern	Recommendation	Priority and Budget		
			Short Term	Mid Term	Long Term
1	Lack of contrast between door and wall on interior of cab.	Modify door finish to provide 70% contrast with adjacent cab wall finishes.			\$1,500
2	No Braille on buttons.	Provide Braille on elevator buttons.	\$1,500		
3	No audible confirmation of buttons pressed.	Modify elevator buttons to provide audible feedback when pressed.		\$5,000	
4	No audible indication of travel direction or floor arrival.	Modify elevator to provide audible feedback indicating travel direction and floor arrival.		\$10,000

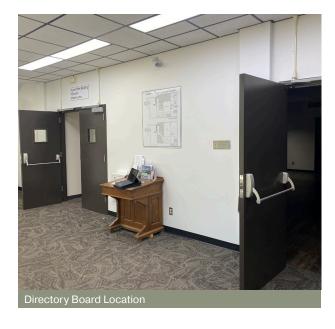
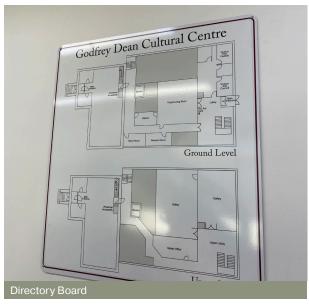
Directory Boards and Information Kiosks

There is one directory board located in the main entrance lobby. The map has glare with graphics that are not clear (i.e. Light weights, contrast, symbols, etc.).
