Accessibility Report

Yorkton

Accessibility Review and Prioritized Recommendations

Project Number: 2025-073

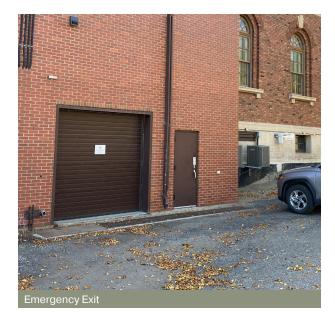
There is no designated area of refuge in the building. The emergency exit from the main floor stair corridor has an elevation change to grate on the exterior.

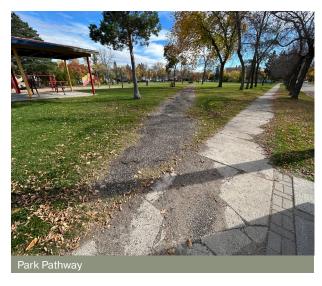
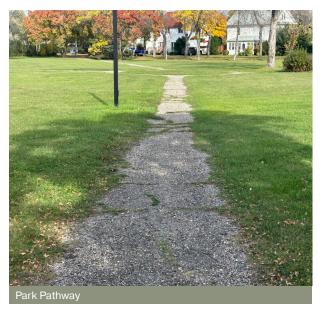
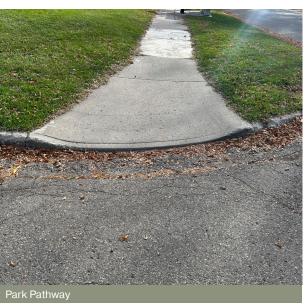
The paved pathways at Jackson Park are in disrepair and do not connect to the park or the covered seating area. The slopes from the sidewalk into the park are also too steep.

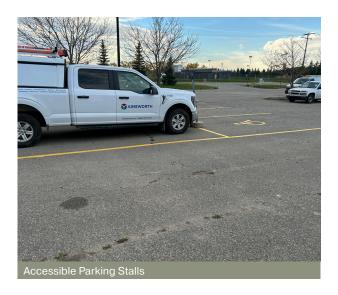
Four accessible parking stalls are provided for the Kinsmen Arena. They are sufficient in width, but lack access to aisles, canopy coverage, and a tactile path to the entrance.

Item	Concern	Recommendation	Priority and Budget		
			Short Term	Mid Term	Long Term
1	No access aisles adjacent accessible stalls.	Create shared access aisles between accessible stalls. Access aisles to be a minimum of 2000 mm wide. Width of accessible parking stalls shall not be reduced to less than 2600 mm to create access aisles. Access aisles can be shared between two adjacent stalls.		\$5,000

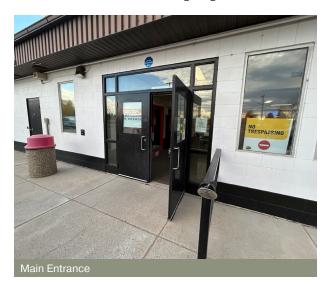
The main entrance is easily identified; however, lacks an entrance canopy, vestibule, and sufficient contrast between the door and adjacent glazing. The push button door actuator is only at one level and was not tested due to the ongoing construction occurring in the building.

Item	Concern	Recommendation	Priority and Budget		
			Short Term	Mid Term	Long Term
1	No building entrance canopy.	Install canopy at building entrance.			\$15,000
2	Only one height of push button door actuator provided.	Revise door actuator control push button to be elongated actuator that can be activated from 400 mm to 1100 mm above ground on both sides of door.	\$2,500		
3	No seating on the exterior of the building.	Install seating at the main entrance.		\$2,500

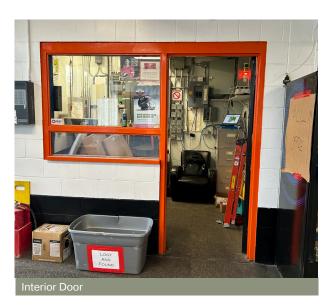
Doors by their very nature act as barriers and can significantly impact the accessibility of a facility. It is important to ensure that doors are equipped with proper hardware, accessible opening widths and are sufficiently contrasted with their surroundings.

Item	Concern	Recommendation	Pric	ority and Bud	dget
			Short Term	Mid Term	Long Term
1	Most doors lack sufficient clear width.	Replace single leaf doors with 1000 mm wide doors, minimum. Ensure vision glazing, accessible hardware, and kickplates are included. Budget assumes 20 doors.			\$60,000
2	Most doors use knob style door handles.	Replace knobs with lever style handles or D pulls. Budgets assumes 20 doors.	\$30,000		
3	Some doors have advertisements on panels that provide poor contrast with surroundings.	Relocate ads to not impede visibility through glass.		\$5,000	
4	Most doors have insufficient contrast with surroundings.	Paint doors and frames to ensure at least 70% contrast with surroundings. Budget assumes 20 doors.			\$20,000
5	Arena door opens quickly.	Program door actuator to open slower.	\$500		
		Sub-total	\$30,500	\$5,000	\$80,000

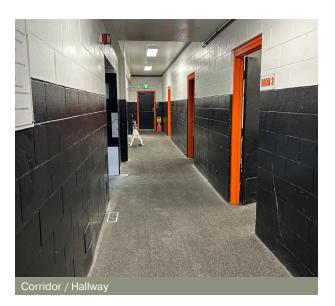
The corridors in the Kinsmen Arena are sufficiently wide enough but lack contrast between the walls and floors. Long stretches or hallway should include a railing.

Item	Concern	Recommendation	Priority and Budget		
			Short Term	Mid Term	Long Term
1	Corridors lack handrails.	Install continuous handrails in long corridors.		\$5,000	
2	Corridors lack sufficient contrast between floors and walls.	Paint / install wall base materials to ensure 70% contrast with floors.			\$1,500
		Sub-total	\$0	\$5,000	\$1,500

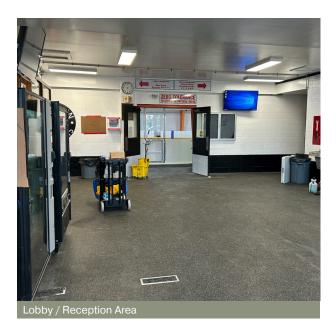
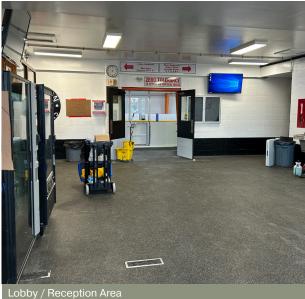
The Kinsmen Arena does not have a permanent reception / ticket booth area.

Item	Concern	Recommendation	Priority and Budget		
			Short Term	Mid Term	Long Term
1	Lack of contrast between floors and walls.	Paint / install wall base materials to ensure 70% contrast with floors.			\$1,500
2	No seating provided.	Provide seating, ensure there is a mix of chairs with and without arms.			\$10,000
Sub-total			\$0	\$0	\$11,500

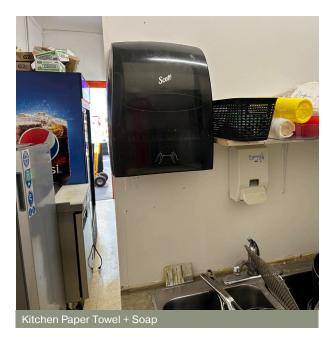
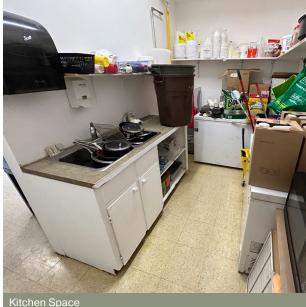
The Kinsmen Arena has a kitchen concession adjacent to the main entrance and within the lobby area. The concession lacks accessible features for the receiving, serving, and preparing.

Item	Concern	Recommendation	Priority and Budget		
			Short Term	Mid Term	Long Term
1	Counters are too high.	Replace millwork to accommodate lower counter. Top of counter to be no more than 860 mm above finished floor.		\$10,000	
2	Serving counter only at one height with no knee space.	Provide accessible height counter, centred on serving counter. Ensure accessible portion has sufficient knee space.	\$5,000		
3	No knee space under sinks.	Replace sink cabinet with version that has knee space. Knee space to be at least 685 mm high.		\$2,500	
4	Paper towel dispenser and soap dispenser too high in concession.	Lower paper towel and soap to be no more than 1100 mm above floor.	\$500

5	Multiple types of floor tiles patched throughout concession creating an uneven surface.	Repair flooring to ensure firm, stable, and smooth surface.		\$10,000	
6	Only one height of coat hooks provided.	Provide secondary, lower height coat hooks. Mount at no more than 1100 mm above floor.	\$500		
7	Lack of contrast between floors and cabinets.	Replace cabinet finishes with versions that have at least 70% contrast with floors.			\$5,000
8	Pinch points in concession caused by furniture placement.	Rearrange furniture to eliminate pinch points.			\$5,000
		\$6,000	\$22,500	\$10,000

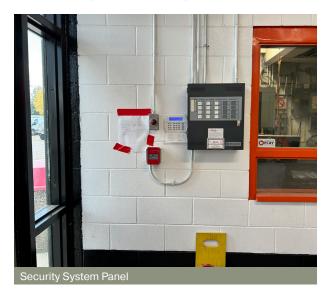
Most building systems throughout the Kinsmen Arena are too high.

Item	Scope	Recommendation	Pric	rity and Bud	get
			Short Term	Mid Term	Long Term
1	Light switches too high.	Lower switches throughout to be no more than 1100 mm above floor.			\$10,000
2	Security panel too high.	Lower panel throughout to be no more than 1100 mm above floor.			\$1,500
3	Water fountain too high.	Lower fountain to accessible height. Spout to be at 900 mm above floor.	\$1,500		
4	No sharps containers.	Provide sharps containers, where appropriate. Mount no more than 1100 mm above floor.	\$500		
5	Thermostat too high.	Lower thermostats to be no more than 1100 mm above floor.			\$1,500
	Sub-total			\$0	\$13,000

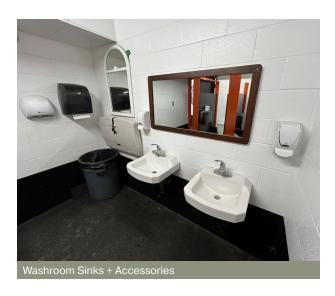
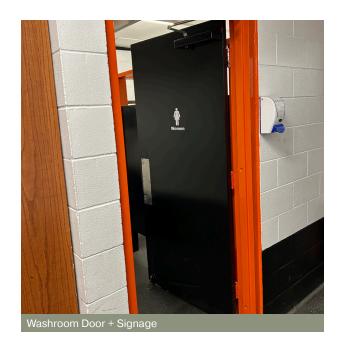
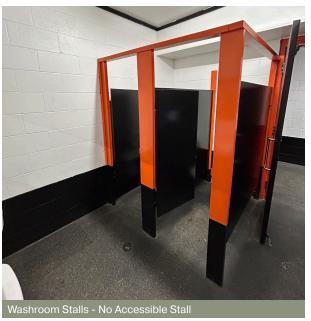
The Kinsmen Arena does not have any accessible washrooms.

Item	Concern	Recommendation	Priority and Budget		
			Short Term	Mid Term	Long Term
1	No accessible washrooms provided on site.	Provide at least one washroom cubicle that meets or exceeds all requirements of CSA-B651-23. Budget is per washroom.	\$75,000		
	Sub-total			\$0	\$0

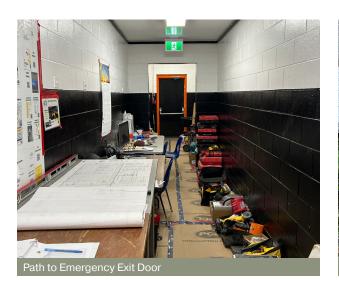
The Kinsmen Arena has multiple emergency exits throughout the facility. Some exit thresholds require a step up, some lead grass path, and some are even but have gaps between the concrete and the building. Hardware is also inconsistent throughout and many exterior pathways are impeded at downspouts where weeping tile has been attached and laid out.

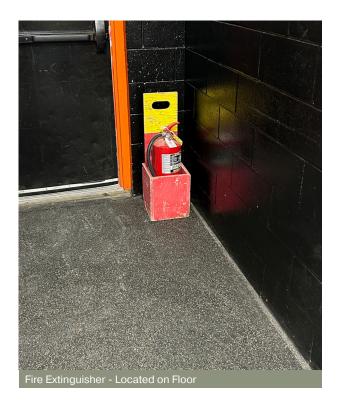
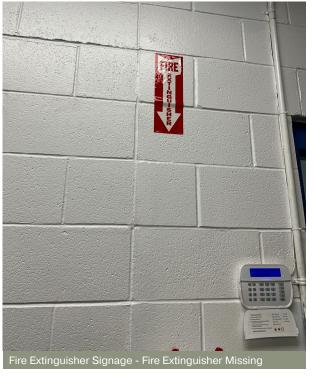
There are fire pulls, an AED and fire extinguishers located throughout the building and strobes located in the Arena. The pulls and AED are located too high. The fire extinguishers are either located too high or have been placed on the ground, in both situations there are no blade signs noting their location. Most exit signs use the green running man, but there is one exit signage that uses red EXIT text in the south west wing.

8	Fire extinguisher sign on door.	Replace signs on doors with latch-side, wall mounted signs.	\$750		
		Sub-total	\$7,750	\$15,000	\$18,000

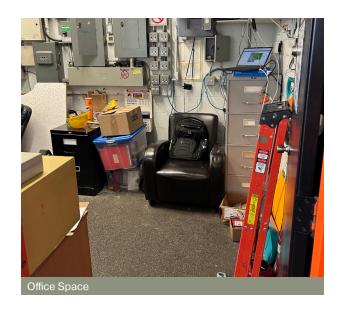
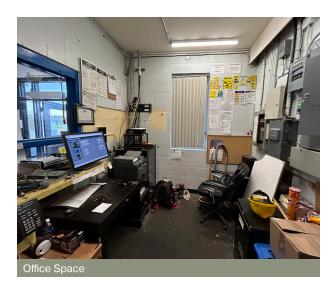
The Kinsmen Arena has one office directly off the lobby space that used to be the reception space. The desk is not height adjustable and while multiple chair options are available, they are both arm style.

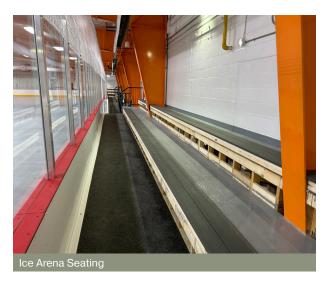
The ice arena utilizes tiered bench seating on the south side of the rink for spectator viewing. A designated accessible seating area is located near the main doors and accessed by ramp. There is no companion seating next to the accessible seating and no toe kicks at the railings. Contrast between the walls and floors is sufficient but it is insufficient between the floors and arena boards. Structural columns imped headroom throughout the arena and are not denoted with tactile flooring.

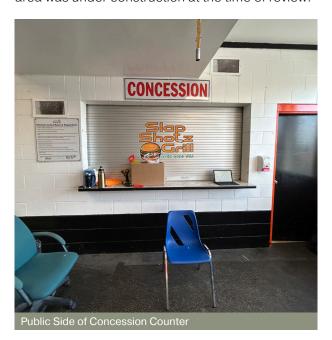
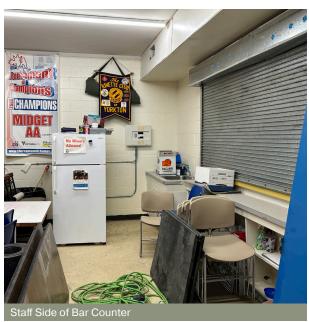
The Kinsmen Arena has a bar located in the south west corner of the facility with an adjacent seating area. The concession lacks accessible features for the receiving, serving, and preparing. The seating area was under construction at the time of review.

Item	Concern	Recommendation	Priority and Budget		
			Short Term	Mid Term	Long Term
1	Counters are too high.	Replace millwork to accommodate lower counter. Top of counter to be no more than 860 mm above finished floor.		\$10,000	
2	Serving counter only at one height with no knee space.	Provide accessible height counter, centred on serving counter. Ensure accessible portion has sufficient knee space.	\$5,000

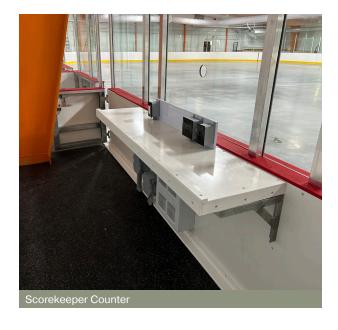
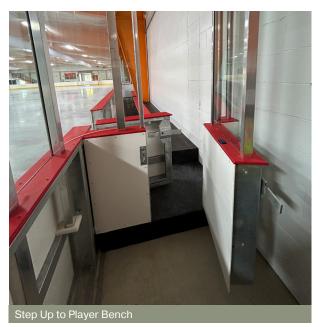
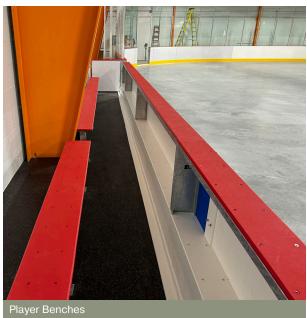
The arena has an ice arena that encompasses the entire north portion of the facility. Player benches, penalty boxes, and the scorekeeper bench are all accessed from the ice sheet and player gates onto and off the ice are too narrow and require a step up.

Item	Concern	Recommendation	Pric	ority and Bud	lget
			Short Term	Mid Term	Long Term
1	Player gates onto ice are too narrow.	Modify 50% of gates to have a minimum of 860 mm clear.			\$6,000
2	Arena player benches and penalty boxes have a step up.	Provide portable ramps for access when required.		\$2,500	
3	Arena player benches and penalty box benches lack arms and backrests.	Provide option for arms and backs on player benches and penalty box benches.			\$2,500
4	Access to player benches from ice only.	Provide accessible path of travel from change room to player benches.			\$10,000
5	Scorekeeper counter only at one height.	Replace stationary scorekeeping counter with height adjustable version.		\$1,500	
		Sub-total	\$0	\$4,000	\$18,500

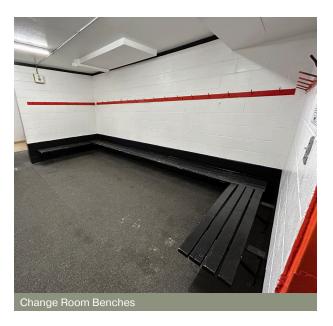
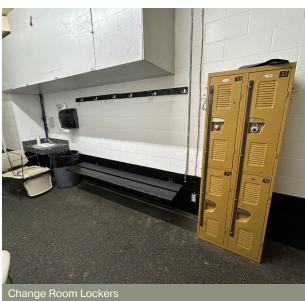
The Kinsmen Arena has five player changerooms and one referee changeroom. All change rooms require intervention to meet accessible guideline standards. There are no accessible washrooms or showers within the change rooms.

Item	Concern	Recommendation	Priority and Budget		
			Short Term	Mid Term	Long Term
1	Lack sufficient contrast between floor and wall.	Paint / install wall base material to ensure at least 70% contrast with floor.			\$2,500
2	Shelves and coat hooks are too high and only at one level.	Provide secondary, lower height coat hooks. Mount at no more than 1100 mm above floor.	\$500		
3	Only one type of seating provided.	Provide a variety of seating in change rooms.			\$10,000

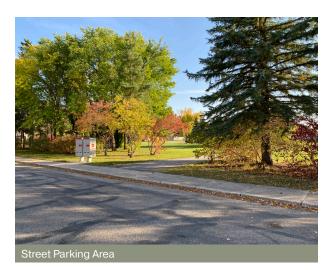
There are no designated parking areas for the park. The street is utilized for parking but lacks curb cuts for access.

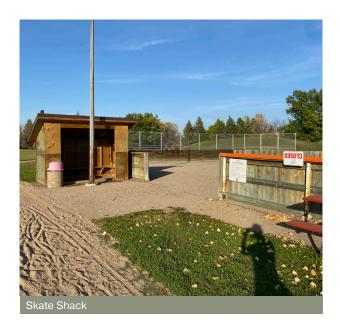
The park features an outdoor rink and tennis court, but they lack an accessible paved path to their respective entrances. The tennis court entrance is difficult to see and blends in with the remaining walls/fencing. A skate shack is provided beside the outdoor rink but it has a curb at its entrance. Overall, there is no seating or shelter provided around the sports facilities. The park also has a slow pitch diamond, but it lacks an accessible pathway to the backstop or field.

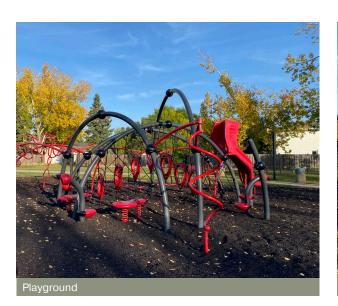
The playground surface is rubber mulch with no accessible play structures provided. There is also a curb around the play area without a cut for access.

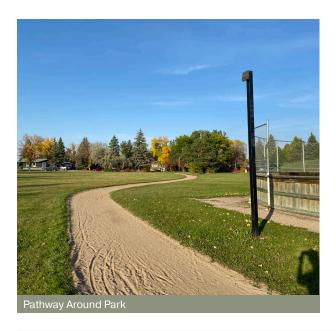
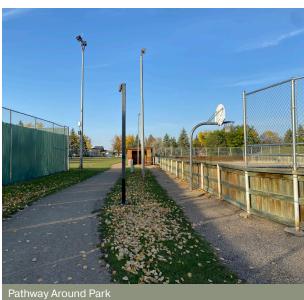
The park has a paved pathway that extends to each entrance. There are benches provided on site, but they lack a shelter and a clear paved space beside them for wheelchairs, service dogs, or strollers. The benches also lack an option with arms.

Item	Concern	Recommendation	Priority and Budget		
			Short Term	Mid Term	Long Term
1	Benches lack clear paved space beside for wheelchairs or service dogs.	Provide clear paved space beside benches to ensure space for wheelchairs or service dogs. Space to be smooth, level, and slipresistant.			\$10,000
2	Benches lack option for arms.	Provide some armed options for benches.			\$2,500
3	No shelter provided over benches.	Install an appropriate shelter above seating.			\$10,000
		Sub-total	\$0	\$0	\$22,500

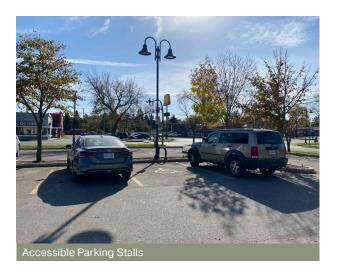
The Public Library has two accessible parking stalls, but they lack access aisles and curb cuts. There is also no path of travel for pedestrians from the parking lot to the entrance. At the back parking lot, there are no accessible parking stalls.

Parking					
Item	Concern	Recommendation	Pric	rity and Buc	lget
			Short Term	Mid Term	Long Term
1	Accessible stalls lack access aisles.	Create shared access aisles between accessible stalls. Access aisles to be a minimum of 2000 mm wide. Width of accessible parking stalls shall not be reduced to less than 2600 mm to create access aisles. Access aisles can be shared between two adjacent stalls.		\$5,000

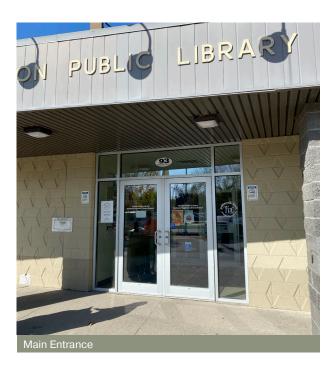
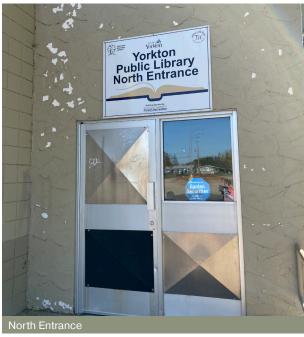
Building Entrances

The entrance to the library is obvious and has a canopy, however, there is no seating provided. The book return box identifiable in its location adjacent to the front doors, but it is too high. The entry doors are glazed and have insufficient contrast with the building. The push button actuators for the doors are single height and blend into the surrounding wall.

At the back entrance, there is no canopy or seating. The concrete in the area is in disrepair while being sloped.

Item	Concern	Recommendation	Pric	ority and Bud	lget
			Short Term	Mid Term	Long Term
1	No seating below canopy.	Install seating at the main entrance under canopy.		\$2,500	
2	Push button actuators are single height and blend into surroundings.	Revise door actuator control push button to be elongated actuator that can be activated from 400 mm to 1100 mm above ground on both sides of door. Ensure location of actuators is obvious and contrasts with surroundings.	\$2,500		
3	Book deposit slot is too high.	Lower book deposit slot to no more than 1100 mm above ground.		\$5,000	
4	Insufficient visual contrast on glazed doors.	Add colour-contrasting strips on full width of door glazing.	\$1,500		
5	Concrete in disrepair at back entrance.	Repair concrete to ensure smooth path of travel at back entrance.	\$10,000		
6	No canopy or seating at back entrance.	Install seating and canopy at back entrance.			\$15,000

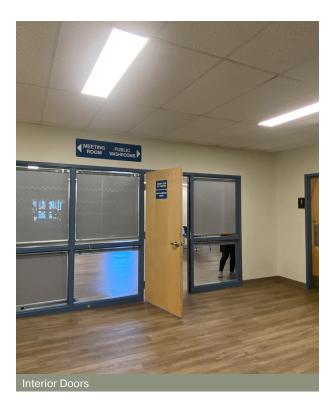
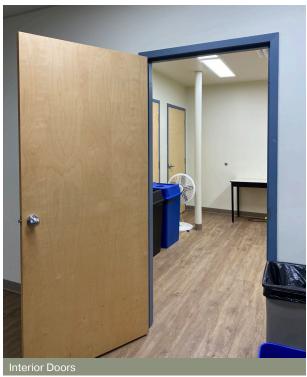
Interior Doors and Doorways (not including Washrooms)

The interior doors typically do not have kickplates and have knobs for hardware—making them difficult to grasp. Additionally, the doors have insufficient clear width.

Item	Concern	Recommendation	Priority and Budget		
			Short Term	Mid Term	Long Term
1	No kickplates.	Install kickplates on interior doors. Budget assumes 20 doors.	\$10,000		
2	Knobs on doors.	Replace door handles with lever style or D pull. Budget assumes 20 doors.	\$30,000		
3	Insufficient clear width.	Replace single leaf doors with 1000 mm wide doors, minimum. Ensure vision glazing, accessible hardware, and kickplates are included. Budget assumes 20 doors.			\$60,000
Sub-total			\$40,000	\$0	\$60,000

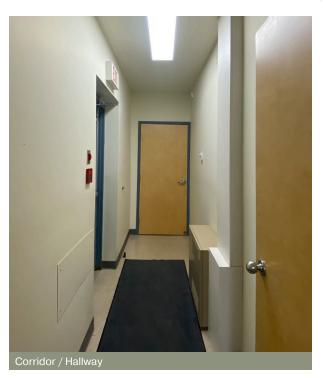
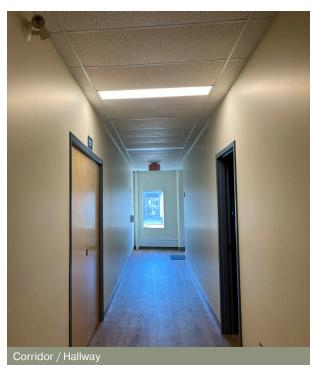
Corridors and Hallways

The corridors have sufficient width, but are quite long while lacking handrails.

Item	Concern	Recommendation	Priority and Budget		
			Short Term	Mid Term	Long Term
1	Long corridor lacks handrails.	Install continuous handrails in long back corridor.		\$5,000	
		\$0	\$5,000	\$0

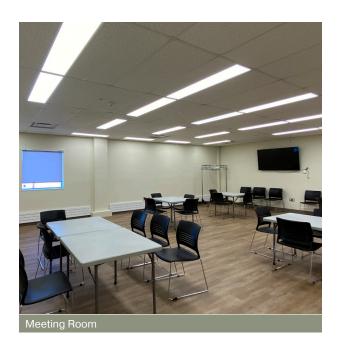
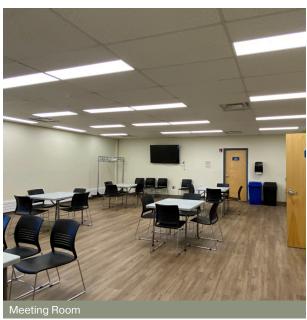
Waiting Areas, General Seating, Meeting Rooms, and Lounges

The meeting rooms have ample space and tables with rounded corners, but only one style of chair is provided. The counters in these rooms are too high and lack knee space at the sinks. There is a coat rack provided, but it is a higher height.

Item	Concern	Recommendation		Priority and Budget			
			Short Term	Mid Term	Long Term		
1	Only one style of chair provided.	Replace seating to ensure a mix of chairs with arms, armless, backless, and with backs.			\$10,000		
2	Counters are too high.	Replace counter with lower, accessible version, no more than 860 mm above floor.		\$10,000

Sub-total			\$12,500	\$10,000
4	Only higher height of coat rod.	Provide secondary, lower height coat rod in meeting room.	\$500		
3	Counter / sink lacks knee space.	Replace sink cabinet with version that has knee space. Knee space to be at least 685 mm high.		\$2,500

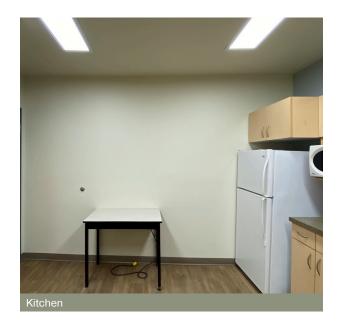
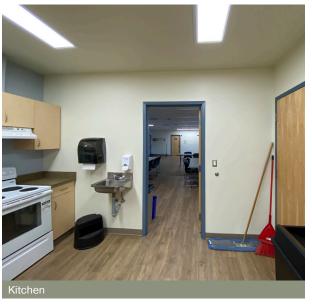
Kitchens

There is a kitchen located off one of the multipurpose/meeting rooms, but it is generally inaccessible. The microwave and freezer are too high, and the stove controls are located at the back of the appliance with its venting controls above as well.

The counter is too high and lacks knee space at the sink with the soap and paper towel dispensers mounted too high. The handwash sink at the entrance is also too high.

Item	Concern	Recommendation	Pri	ority and Bud	lget
			Short Term	Mid Term	Long Term
1	Microwave is too high.	Lower microwave to counter height. Ensure clear space beside microwave is provided.	\$500		
2	Stove has controls on back of appliance.	Replace stove so all controls are located at front of appliance.			\$2,500
3	Fridge is freezer-on-top style.	Replace fridge with freezer-on-bottom style.			\$2,500
4	Sinks lacks knee space.	Replace sink cabinet with version that has knee space. Knee space to be at least 685 mm high.		\$2,500	
5	Handwash sink is too high.	Replace sink cabinet with version that has knee space. Knee space to be at least 685 mm high.		\$2,500	
6	Paper towel is too high.	Lower paper towel to no more than 1100 mm above floor.	\$500		
7	Counters are too high.	Replace counter with lower, accessible version, no more than 860 mm above floor.		\$10,000	
		Sub-total	\$1,000	\$15,000	\$5,000

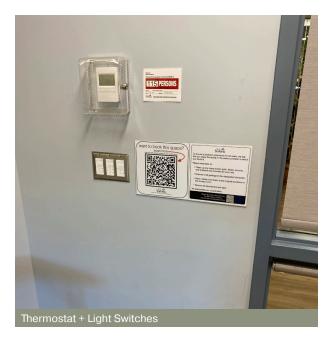
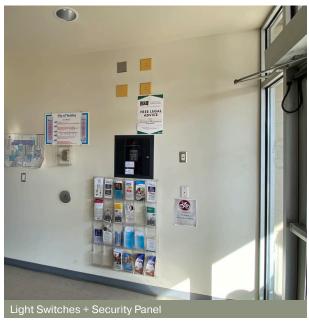
Acoustics, Illumination, and Building Systems

The thermostats, light switches, and security panel are typically too high throughout the building. There is a water fountain near the washrooms, but it is too high and lacks sufficient knee space.

Item	Scope	Recommendation	Pric	ority and Bud	dget
			Short Term	Mid Term	Long Term
1	Thermostats are too high.	Lower thermostats to no more than 1100 mm above floor.			\$5,000
2	Light switches are too high.	Lower light switches to be no more than 1100 mm above floor.			\$10,000
3	Fountain is too high and lacks sufficient knee space.	Replace drinking fountains with accessible knee space fountains. Ensure new fountains are mounted at accessible height. Include TAIs or guards to make fountains cane detectable.	\$2,500		
4	Security panel is too high.	Lower security panel to be no more than 1100 mm above floor.			\$1,500
	Sub-total			\$0	\$16,500

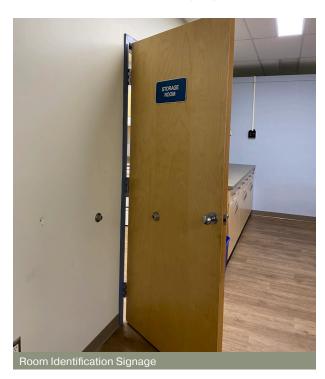
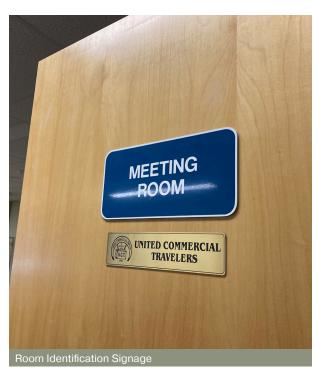
Room Identification Signage

There is room identification signage provided on doors that lacks tactile and Braille components.

Item	Concern	Recommendation	Priority and Budget		
			Short Term	Mid Term	Long Term
1	Signage is located on doors and lacks tactile and Braille components.	Replace signs on doors with latch-side, wall mounted signs at 1500 mm. Signage to be high contrast, tactile, and include Braille.	\$15,000		
	Sub-total			\$0	\$0

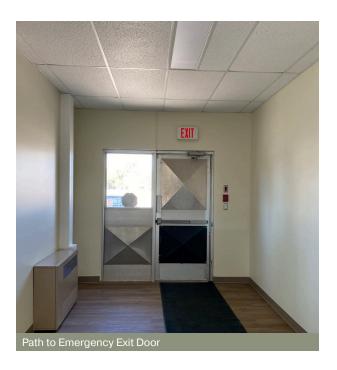
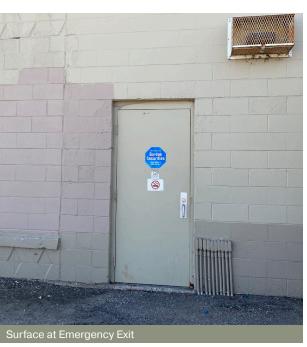
Emergency Exits and Areas of Refuge

While the exits have pathways leading away from the building, they have non-level thresholds.

Item	Concern	Recommendation	Priority and Budget		
			Short Term	Mid Term	Long Term
1	All exits have pathways leading away from building but have non-level thresholds.	Revise door thresholds to be level or have low slope ramp to pathways.	\$7,500		
Sub-total			\$7,500	\$0	\$0

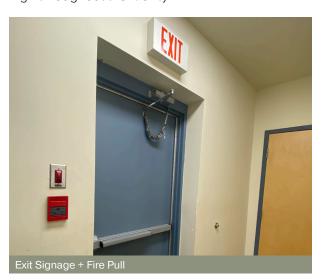
Fire Alarm Systems and Equipment

There is an AED and fire extinguisher provided on site but they are mounted too high. The exit signage is the old style red EXIT signs, rather than the current standard green signage. The fire pulls are also too high throughout the facility.

Item	Concern	Recommendation	Pric	Priority and Budget		
			Short Term	Mid Term	Long Term	
1	Fire extinguishers are too high.	Lower fire extinguishers to no more than 1100 mm above floor.			\$1,500	
2	Kitchen extinguisher is impeded.	Relocate fire extinguisher to ensure there is clear access.	\$500			
3	Exit signage is old style red EXIT signs.	Replace exit signage with green running man style signs.	\$15,000			
4	Fire pulls are too high.	Lower fire pulls to no more than 1100 mm above floor.			\$15,000	
5	AED is too high.	Lower AED to no more than 1100 mm above floor.	\$500			
	Sub-total			\$0	\$16,500

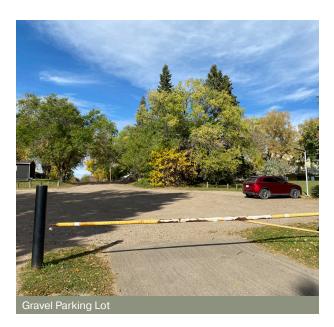
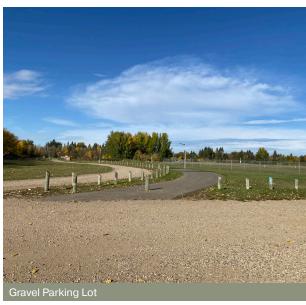
The parking lots for Logan Green are gravel and lack accessible stalls. Parking stalls also lack indication through painted lines or vertical signage. The entrance from the north parking lot is blocked by a gate and the south entrance lacks an accessible path to the parks facilities.

Item	Concern	Recommendation	ndation Priority and Budge		
			Short Term	Mid Term	Long Term
1	Parking lots are gravel.	Pave parking lots to provide smooth, stable, and slip resistant surface.	\$500,000		
2	Parking lots lack accessible stalls.	Provide accessible stalls. Include 2 meter access aisle on at least one side of the stalls. Stall dimensions to meet or exceed CSA-B651-23. Include signage designating accessible stalls.	\$10,000

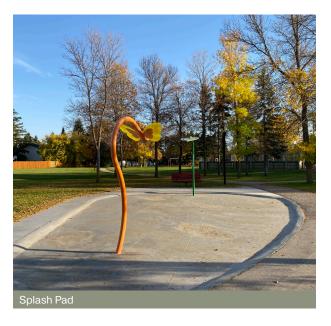
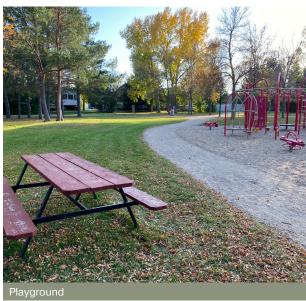
The playground surface is sand with no accessible play structures provided. The playground features a splash pad, but it lacks contrast and tactile edge protection. A bench is provided near the splash pad, but it lacks an option with arms or a shelter above.

Item	Concern	Recommendation	Priority and Budget		
			Short Term	Mid Term	Long Term
1	Ground surface is sand.	Renovate play areas to have rubber paving, level with surrounding ground.	\$15,000		
2	No accessible play structures provided.	Install or supply accessible play structures.		\$50,000	
3	Splash pad lacks contrast and tactile edge protection.	Install tactile and contrast edge protection on splash pad.		\$5,000	
4	Splash pad bench lacks option for arms.	Provide arms on 50% of the benches.			\$2,500
5	Splash pad bench lacks shelter above.	Install an appropriate shelter above splash pad seating.			\$15,000
		\$15,000	\$55,000	\$17,500

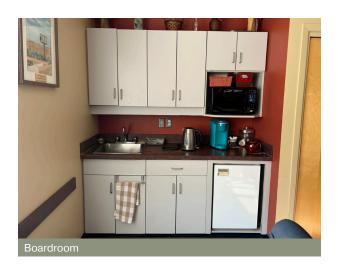
Waiting Areas, General Seating, Meeting Rooms, and Lounges

The boardroom within the Tourist information building lacks many guideline components to make it accessible. Many items are too high and there is a lack of height variation throughout the space.

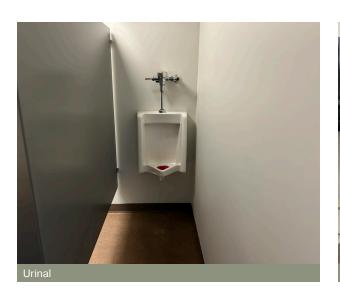
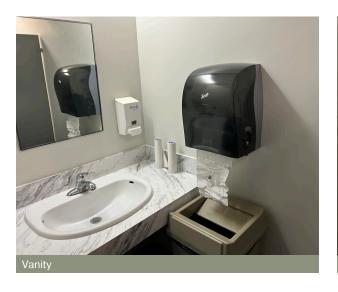
Accessible washrooms are located off the entry vestibule. Adjustments to these washrooms are required for them to comply with accessibility guidelines.

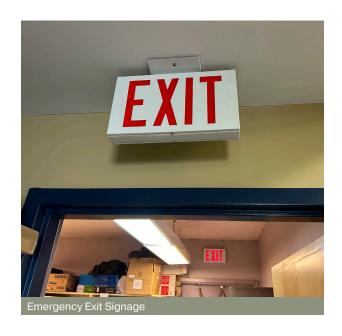
Fire Alarm Systems and Equipment

Emergency exits are all denoted with old signage that uses red EXIT text and should be updated to the new green running man signage.

There is no AED or fire strobes in the building.

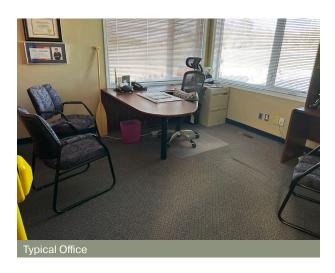
There are two individual offices and one shared office within the Tourist Information Building. The two individual offices are very large with sufficient maneuvering space. The shared office has some pinch points caused by furniture placement. There are no height adjustable desks and only one type of seating is provided.

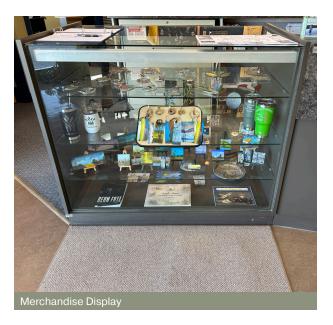
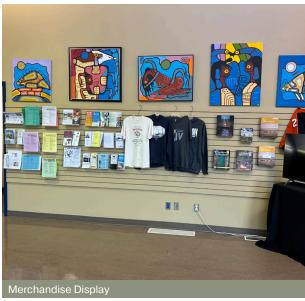
Retail Outlets

A retail outlet is attached to the reception area and lobby. The retail sells local artwork and some clothing items. The prices for the merchandise are not clearly displayed, and some of the products are impeding travel paths.

Item	Concern	Recommendation	Priority and Budget		
			Short Term	Mid Term	Long Term
1	Prices for merchandise are insufficiently displayed.	Provide clear and easy-to- read pricing for all items.		\$2,500	
	Sub-total			\$2,500	\$0
